REAL INTERSECTION DESIGN

leaving theory behind for design

a Professional Development Workshop for the
Metropolitan Washington Council of Governments
Riverdale MD
21 November 2003

Intersection of Kenilworth Avenue and Riverdale Road, view from the southwest

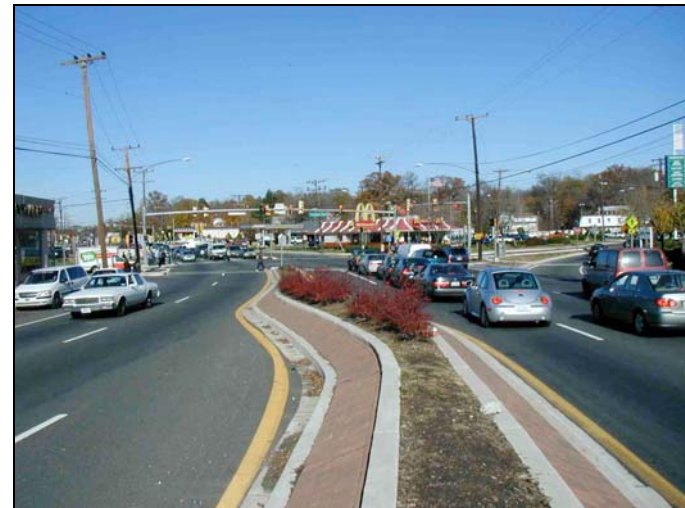
Figure 9: Median on Kenilworth Avenue

Kenilworth Avenue is 70 feet wide with a raised median that varies in width from four to eight feet wide (Figure 9). Traveling southbound there are two 11-foot wide lanes plus a left turn bay. Northbound there are three 11-foot wide lanes plus a left turn bay. The cycle length is 150 seconds.

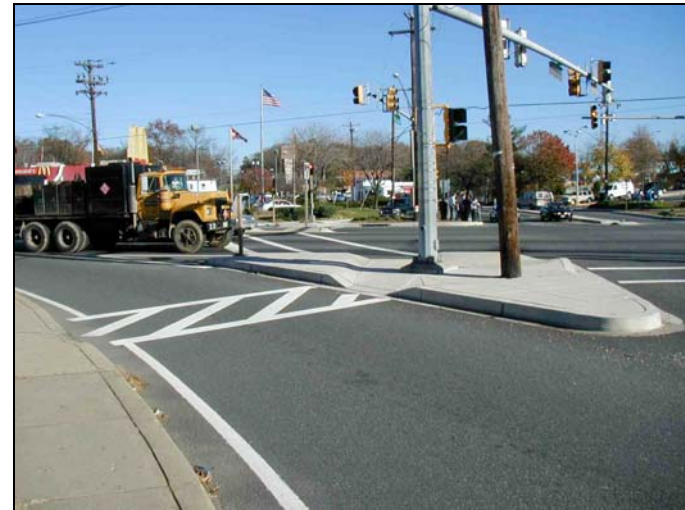
Figure 10: Typical Crosswalk Alignment

Crossing the intersection is complicated by the non-linear crosswalk alignment and driver disregard of walkers (Figures 10-11).

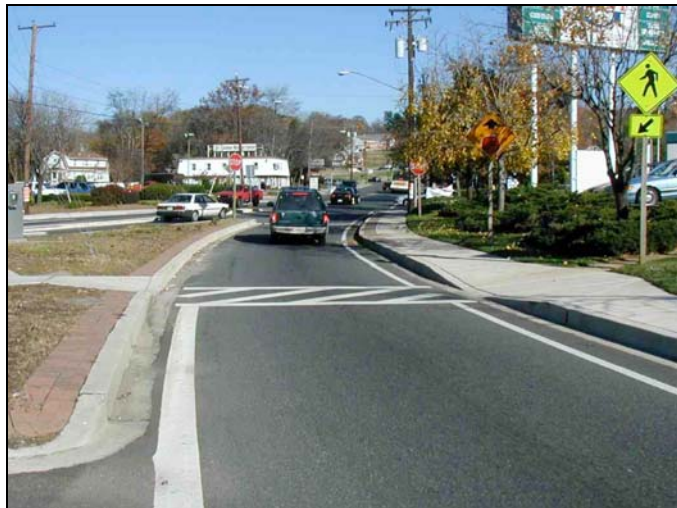
Figure 15: Slip Lane with Crosswalk ahead of Stop Sign

A spot speed survey was performed during the workshop, see Table 4. Free-flow 85th percentile speeds on Kenilworth Avenue (32-33 mph) were well within the range for a suburban arterial. Speeds on Riverdale Road, while only 30 mph, may be considered high for this type of street. Most interesting were the speeds (25 mph) recorded on the slip lane between northbound Kenilworth Avenue and eastbound Riverdale Road. Here there is

a crosswalk, stop sign and driveway access, yet the geometry clearly allows this pace (Figure 15).

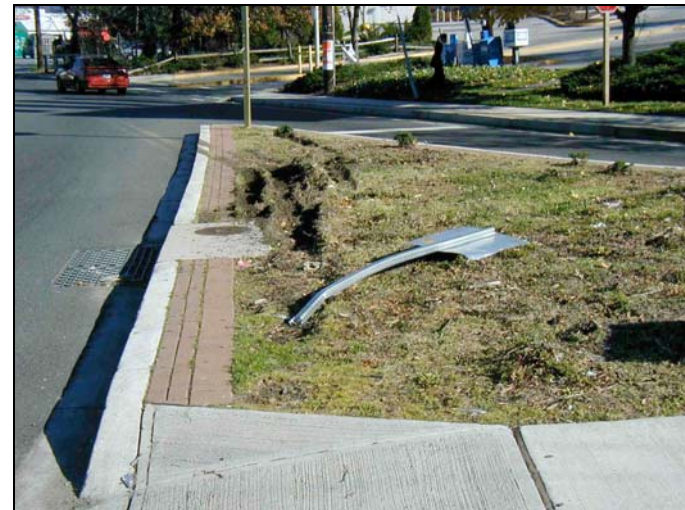
Figure 16: Recent Crash Remnants

Thirty-two vehicular crashes were recorded in the three years since the reconstruction (Jan 00 – Dec 02). The highest percentage of accidents occurred during off-peak hours, followed by the PM peak period. Almost forty percent of the crashes were rear-end collisions, usually caused by lack of attention by the driver and/or excessive speed. Over fifteen percent of the crashes were sideswipes. Over twenty percent of the crashes were left-turn collisions, while twenty-five percent were angle crashes. General disregard for signals can be the cause of angle crashes. Over the two-year period these thirty-two crashes resulted in eighteen injuries and one fatality. The one fatality was an angle crash, between a SB vehicle going straight and a NB vehicle turning left. Just before the workshop a vehicle(s) turning left from SB Kenilworth Avenue onto EB Riverdale Road ran over a sign in the median and left tracks in the triangle (Figure 16).
