CITY OF FAIRFAX

# Main Street Road Safety Audit Final Report

Metropolitan Washington  
Council of Governments

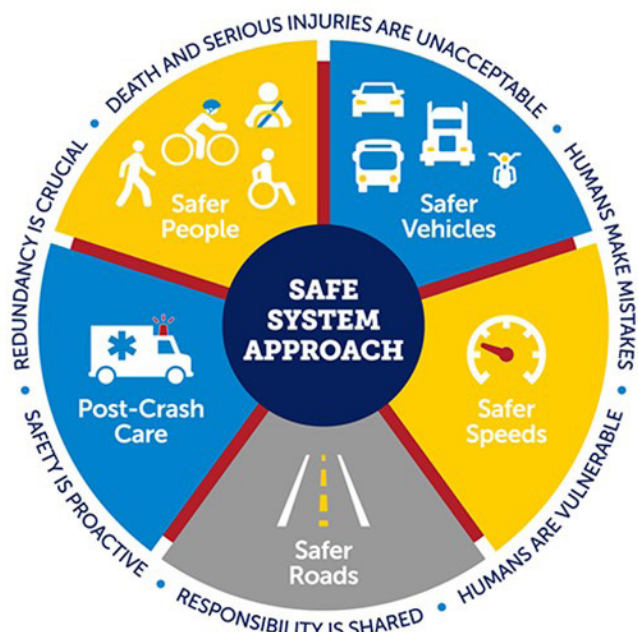
**Figure 1.** Elements and principles of the Safe System Approach (Source: FHWA)

This RSA also incorporates principles of the Safe System Approach, which aims to reduce fatalities and life-changing injuries on our roadway system.<sup>1</sup> This involves enhancing transportation systems through five elements: safer people, safer roads, safer vehicles, safer speeds, and post-crash care (shown in **Figure 1**). This study offers recommendations for enhancing safety, and emphasizes the role of education, engagement, enforcement, and emergency response in preventing serious crashes.

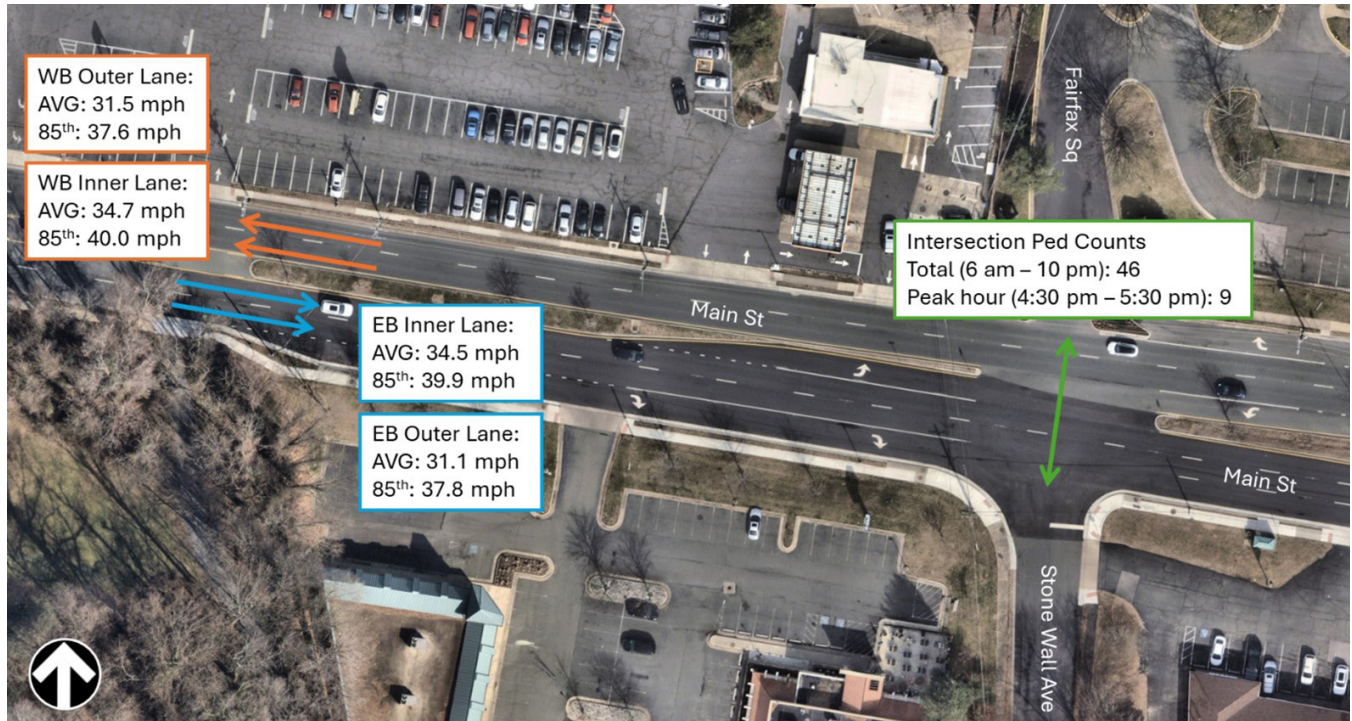
Figure 3. Location of ATRs on Main Street west of Fairfax Square / Stone Wall Avenue

The eastbound and westbound directions had similarly high 85th percentile travel speeds, approximately 5 mph and 4 mph over the posted speed limit, respectively. The following tables show the summaries of speed data for each direction and associated lane at this location.

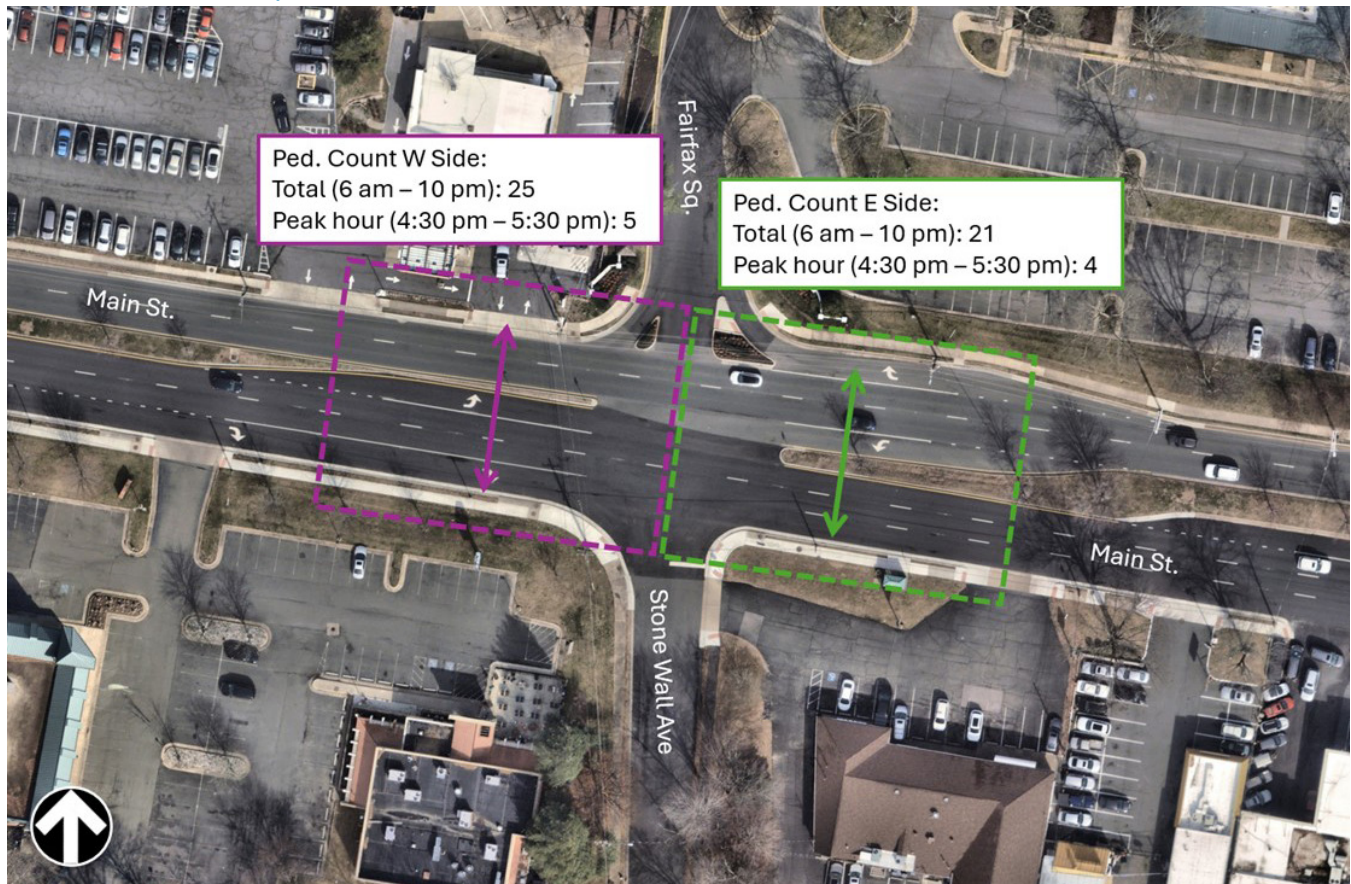
As part of this RSA and identified safety concerns, pedestrian data was collected within a 300-foot buffer of Main Street at Stone Wall Avenue / Fairfax Square. 16-hour pedestrian count data was collected on May 7, 2024, from 6:00 am to 10:00 pm. Weather conditions during this data collection were dry and cloudy, with a high of 81° F and a low of 64° F. This pedestrian count data was collected using Miovision cameras located on light posts on the northwest and southeast corners of the intersection. **Figure 5** shows an overview of the pedestrian data collected on Main Street 150 feet on either side of Stone Wall Avenue / Fairfax Square.

**Figure 5. Pedestrian count data collected at the intersection of Main Street and Stone Wall Avenue / Fairfax Square**

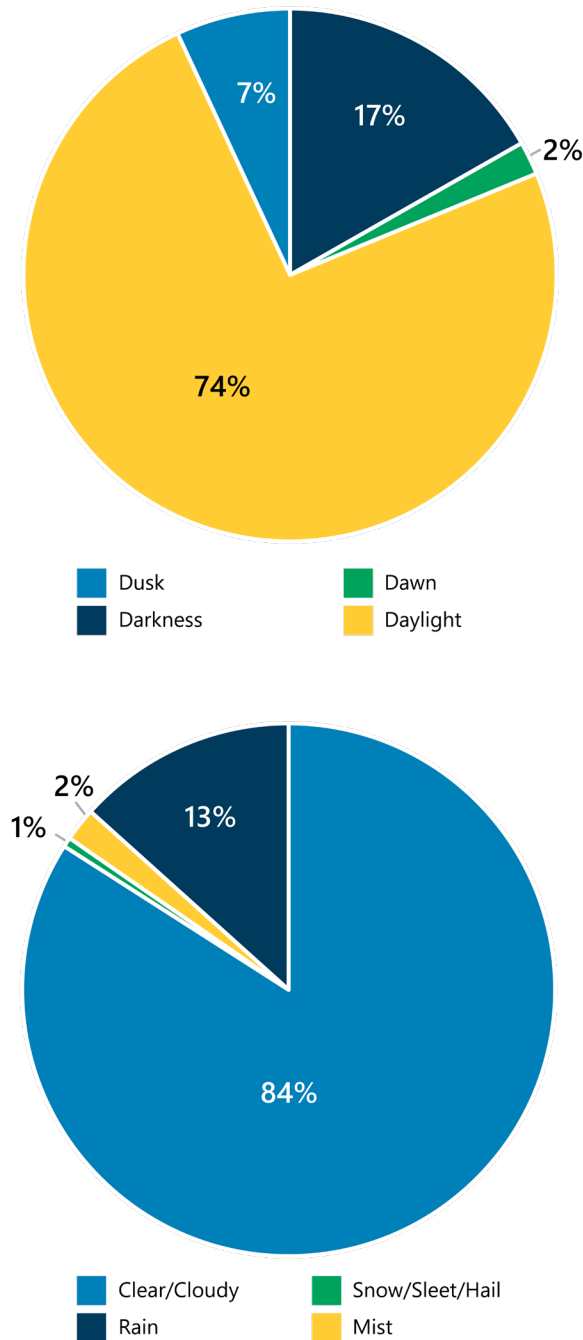
A review of the lighting and weather conditions for crashes within the study area was also reviewed for common trends. **Figure 9** shows that most crashes occurred during daylight (74 percent) and dry conditions (84 percent). Other common themes with respect to lighting conditions was the presence of sun glare when heading east on Main Street in the morning and west in the evening, and the influence it has on rear end crashes at signalized intersections.

**Figure 9. Lighting and weather conditions for crashes on Main Street**

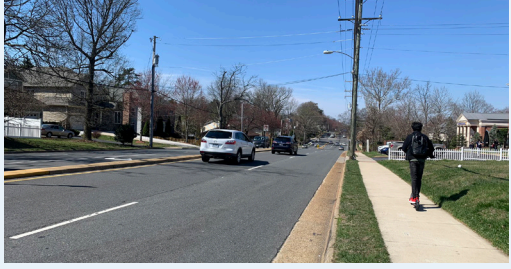
Safety Concern/ Observation	Vehicle	Peds	Bikes	Transit User	Safety Concern Description	Reference Photo	Potential Countermeasure(s)
CORRIDOR WIDE	»	Lack of bicyclist/micromobility facilities			●		There are no separated bicycle facilities along the corridor, until the Fairfax City Bike Trail and Daniels Run Trail on the west end. This leaves bicyclists to either share the road with high volume and high-speed traffic or use the sidewalk, though biking on the sidewalk is generally not permitted by the city code in most areas.	<p>Figure 14. E-scooter user riding on the sidewalk along Main Street</p>

<ul style="list-style-type: none"> <li>» Sidewalk widening improvements</li> <li>» New shared-use path</li> <li>» Exclusive shared transit-bike lane</li> </ul>
	»	Low lighting levels	●	●	●	●	<p>There is low-level lighting along the corridor for pedestrians, particularly at crossing locations. This can make it difficult for drivers to see pedestrians in the crosswalk or waiting to cross.</p> <p>Lighting placement also makes a difference in the effectiveness. At some locations on the corridor, lighting is placed within and between tall trees.</p>	<p>Figure 15. Dimly lit northeast corner of Main Street and Pickett Road</p>

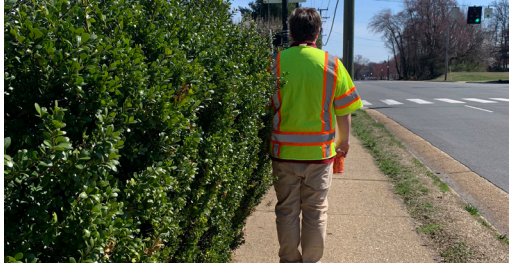
»	Debris in and around storm drains, curb ramps, and gutters		●	●		Debris was observed in the stormwater infrastructure and near curb ramps. This debris can cause stormwater facilities to back up and eventually flood, as well as pose a safety concern for bicyclists riding near the curb as it increases the risk of skidding or losing control of the bike.		<ul style="list-style-type: none"> <li>» Roadway maintenance</li> </ul>
	»	Narrow sidewalks throughout the corridor		●	●	●	Sidewalks are present on both sides of Main Street throughout the study area, though some are narrow and have little separation from the adjacent travel lanes. This can cause discomfort among pedestrians walking close to traffic, as well as challenges for people in wheelchairs, using strollers or carts to navigate around one another. Additionally, the lack of bicyclist facilities can result in pedestrians, bicyclists, and e-scooters all using the narrow sidewalk, meaning passing movements may be challenging or uncomfortable. This can also result in pedestrians walking outside of the crosswalk, potentially in the roadway for short distances.	<p>Figure 16. Foliage infringing on an already narrow sidewalk on Main Street</p>

<ul style="list-style-type: none"> <li>» Shared-use path improvements</li> </ul>

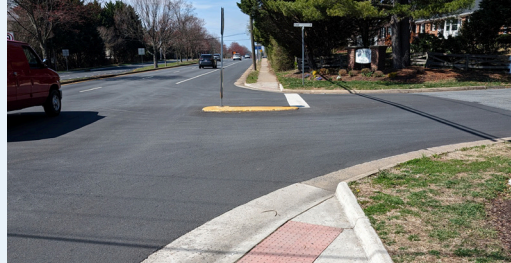
»	Pedestrian crossings on side streets are often unmarked or aligned with stop line		●	●	●	Pavement markings such as stop lines and crosswalks provide driver and pedestrian guidance on where drivers are to stop prior to the intersection as well as where pedestrians are likely to be crossing. At many locations on the corridor, the unmarked crosswalk falls within the space where a vehicle would be stopped waiting to turn onto Main Street. This poses a risk to pedestrians looking to cross at the same time – they must either cross in front of the stopped vehicle (near moving vehicles on Main Street) or behind the stopped vehicle, which then poses a risk of vehicles turning onto the side street not seeing them cross.	<p>Figure 17. Stop sign and median within pedestrian crossing at Estel Road</p>

<ul style="list-style-type: none"> <li>» Crosswalk visibility enhancements</li> <li>» Curb extensions/corner improvements</li> <li>» Curb ramp improvements</li> </ul>

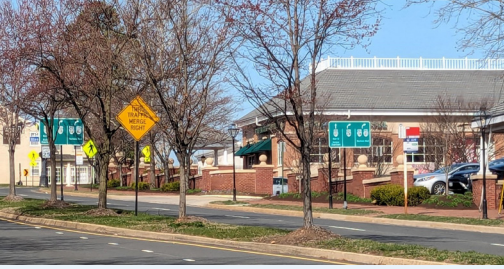
» Left turn crashes at signalized intersections	●	●	●	●	The crash history shows crashes involving left turns and conflicting through traffic at the signalized intersections.		<ul style="list-style-type: none"> <li>» Flashing yellow arrow for left turns</li> </ul>
	» Sight distance challenges on stop-controlled side streets	●	●	●	●	Some of the uncontrolled side streets have foliage and other objects obstructing sight lines for drivers to see oncoming traffic to merge onto or cross Main Street. These sight distance challenges can result in the need for drivers to pull up closer or often into the path of the pedestrian crossing. Safety concerns include an elevated risk of angle crashes involving vehicles entering from approaches at unsignalized intersections.		<ul style="list-style-type: none"> <li>» Roadway maintenance /Vegetation trimming</li> </ul>
	» Vegetation in the median.	●				Vegetation in the median restricts sight distances for the left and right-turning vehicles from side streets when lower branches are not appropriately trimmed. Also, vegetation can restrict the views of signs posted in the median.	<p>Figure 22. Sign obstructed by vegetation to the east of Blenheim Boulevard</p>

<ul style="list-style-type: none"> <li>» Roadway maintenance / Vegetation trimming</li> </ul>

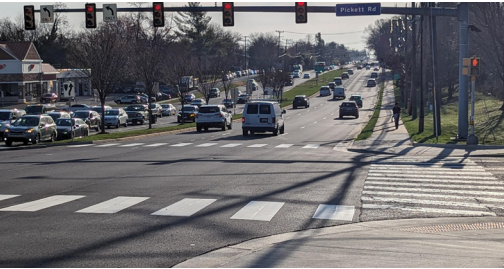
» Queue Spillback at signalized intersections	●	●	●	●	Queue spillback on Main Street at signalized intersections blocks traffic movement from side streets/commercial driveways.	<p>Figure 23. Queueing on the westbound approach at the Main Street and Pickett Road intersection</p>

<ul style="list-style-type: none"> <li>» Signal timing improvements</li> </ul>
	» Pedestrians crossing Main Street at unmarked locations	●	●		●	Pedestrians were observed crossing Main Street at midblock where there were no pedestrian crosswalks or warning signs for motorists.	<p>Figure 24. Pedestrian crossing Main Street at a midblock location to the east of Blenheim Boulevard</p>

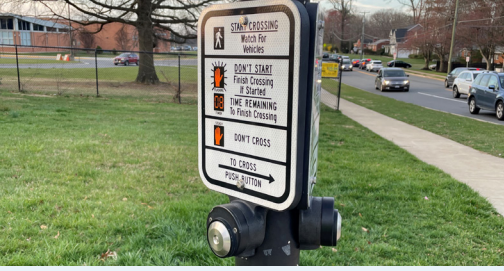
Safety Concern/ Observation	Vehicle	Peds	Bikes	Transit User	Safety Concern Description	Reference Photo	Potential Countermeasure(s)
MAIN STREET AND WHITACRE ROAD (CONTINUED)	» Pedestrian push buttons		●		●	The push buttons are not angled properly in the direction of the crossing across Main Street. The southeast corner push buttons are also separated by a curb and may impede accessibility to the button.	<p>Figure 31. Pedestrian push buttons on the northeast corner of Main Street and Whitacre Road.</p>

» Pedestrian signal improvements
	» Crosswalk landing		●		●	The northeast corner of the intersection has a situation where the east crossing simply ends within the roadway		» Curb ramp improvements
	» Inconsistent speed limit	●				School limit posted west of Whitacre Road is then overruled by the regular speed limit east of Whitacre; turning vehicles from Whitacre onto eastbound Main Street does not see the school speed limit. This concern is also present in the westbound direction of Main Street, west of Pickett Road.		» School zone improvements

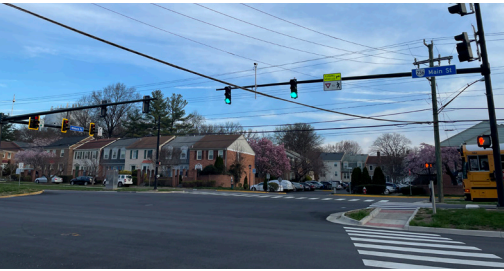
» Retroreflective backplate	●				High visibility backplates are present on the signal heads to the westbound direction of Main Street, but not the eastbound direction. The lack of backplates on this east-west corridor may result in drivers experiencing issues with signal visibility during hours when sun glare is a challenge.	<p>Figure 32. Traffic signal at Main Street and Whitacre Road</p>

» High visibility backplates
MAIN STREET AND LYNDHURST DRIVE / TRAPP ROAD	» Multiple Threat and Long Uncontrolled Crossing		●		●	<p>The total pedestrian crossing length across Main Street at Lyndhurst/Trapp is over 100 ft wide with no control device for drivers when pedestrians are crossing. Given the high traffic volumes and number of lanes to cross, it is difficult and unsafe for a pedestrian to find an available gap in traffic to cross or for all lanes of travel to yield appropriately for a crossing pedestrian.</p> <p>Furthermore, drivers in one lane may opt to stop for the crossing pedestrian, but block the visibility between the driver in the adjacent approaching lane and the pedestrian crossing in front of the stopped vehicle. This can result in a severe pedestrian injury or fatality if the vehicle in the adjacent lane does not stop for the pedestrian.</p>	<p>Figure 33. Long uncontrolled pedestrian crossing at Main Street and Lyndhurst Drive / Trapp Road</p>

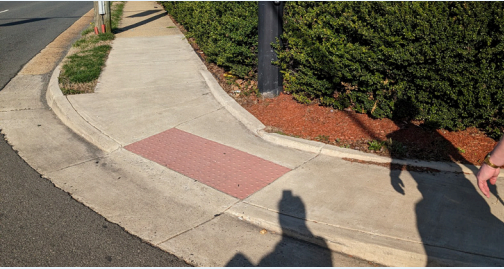
Safety Concern/ Observation	Vehicle	Peds	Bikes	Transit User	Safety Concern Description	Reference Photo	Potential Countermeasure(s)	
MAIN STREET AND TEDRICH BOULEVARD		» Short walk phase crossing Main Street		●		●	The pedestrian phase to cross Main Street at Tedrich Boulevard is an exclusive phase, but the WALK time is only 4 sec. This limits the amount of time for a pedestrian to enter the crosswalk.		» Leading pedestrian interval » Pedestrian signal improvements	
		» Limited landing pad				●	●	There is limited space on the northeast and northwest corners at Main Street and Tedrich Boulevard for pedestrians to wait to enter the crosswalk. This can result in people who rely on mobility devices having challenges entering the sidewalk from the roadway.	<p>Figure 38. Limited landing area for curb ramp on the northwest corner of Tedrich Boulevard at Main Street</p>

» Curb ramp improvements

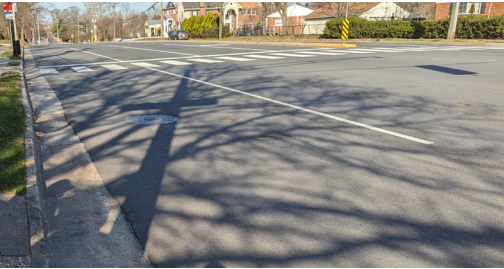
» Inadequate pavement markings and signing		●				The outermost lane on the eastbound approach of Main Street lacks a right-turn-only lane using arrow marking and lane control signs for this approach (left turn/through/through/right turn). Drivers are likely to confuse the outermost lane as the shared through/right turn lane whereas it is a right turn-only lane leading to the United Alliance entrance.	<p>Figure 39. Missing right turn lane marking on the eastbound approach of the Main Street and Tedrich Boulevard intersection</p>

» Main Street and Tedrich Boulevard Improvements
		» Missing Pedestrian Push Buttons			●		●	There are currently no push buttons on the northeast corner of the Main Street and Tedrich Boulevard intersection for the pedestrian crossing across Tedrich Boulevard. This is a safety concern as there is no way for a pedestrian on the east side of Tedrich Boulevard to activate the pedestrian signal to cross during off-peak and night hours when the signal operates in a free or flashing mode and there is no pedestrian recall. Additionally, a pedestrian push button for an accessible pedestrian signal can be activated by someone visually impaired and alert them of when to cross.	<p>Figure 40. Northeast corner of Main Street and Tedrich Boulevard without pedestrian push buttons</p>

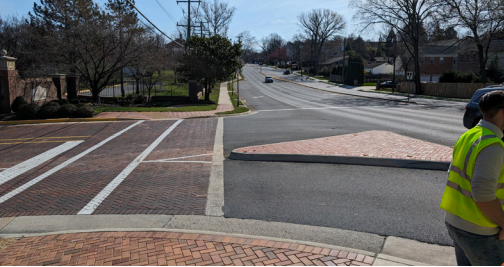
Safety Concern/ Observation	Vehicle	Peds	Bikes	Transit User	Safety Concern Description	Reference Photo	Potential Countermeasure(s)
MAIN STREET AND FARRCROFT DRIVE / ROBERTS ROAD	» No pedestrian signal heads for Farrcroft Drive crosswalk		●		●	There are no pedestrian signal heads for the Farrcroft Drive crosswalk due to the lack of available power on that intersection approach and because Farrcroft Drive is a private road. This can lead to difficulty in judging when to cross that leg of the intersection.	<p>Figure 41. Crosswalk across Farrcroft Drive at Main Street</p>

» Pedestrian signal improvements
	» Turning conflicts between vehicles and crossing pedestrians		●		●	Due to the phasing of the signal, there are conflicts between northbound left turn and southbound right turn vehicles with pedestrians crossing Main St. This can lead to an increase in drivers not yielding to crossing pedestrians.		» Leading pedestrian interval

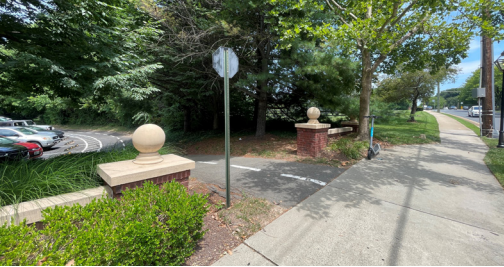
DANIELS RUN TRAIL	» Lack of Wayfinding Between Trails		●	●		There is a lack of wayfinding from where the Fairfax City Bike Trail crosses Main Street at the shopping center to where Daniels Run Trail intersects the sidewalk 400 feet to the west. This can lead to pedestrians and cyclists crossing outside of the signalized intersection or trying to navigate the shopping center parking lot.	<p>Figure 42. Daniels Run Trail Entrance/Exit without wayfinding signs</p>

» Trail wayfinding signage
MAIN STREET AND MARKETPLACE DRIVEWAY	» Missing Pedestrian Signal Heads		●		●	There are currently no signal heads for the pedestrian crossing across Marketplace Driveway. This is a safety concern as there is no way for a pedestrian on the northeast corner of the intersection to activate the pedestrian signal to cross the Marketplace Driveway. Although pedestrians are likely able to cross the full length of the driveway when Main Street has a green indication, other times when the signal is operating free (after 11 pm), a vehicle exiting the Marketplace driveway could trigger a phase change while a pedestrian is crossing the driveway. The phase change would take at least 6 seconds to allow for the yellow and all red clearance interval for Main Street, which is less than the needed walk time to cross the driveway. A driver, especially under dark conditions and lighting levels at the intersection, may not see the pedestrian crossing in front of their vehicle.	<p>Figure 43. Crossing across Marketplace Driveway at Main Street without pedestrian signal heads</p>  	» Pedestrian signal improvements

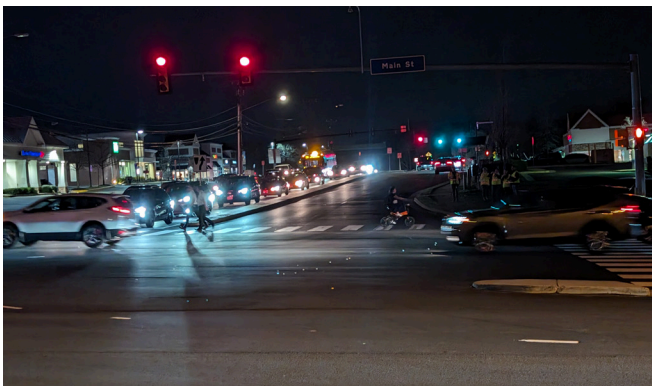
**Figure 45. Pedestrians and bicyclists crossing in north crosswalk at Main Street and Pickett Road**

There are low lighting levels along the corridor for pedestrians, particularly at marked crosswalk locations across Main Street. **Figure 45** shows the darkness of the crosswalk across Pickett Road at Main Street with crossing pedestrians and a bicyclist. Without adequate lighting, it can be difficult for drivers to see pedestrians in the crosswalk or waiting to cross. Lighting placement also makes a difference in the effectiveness, as placement behind or above the pedestrian from the perspective of the approaching driver creates a silhouette effect on the crossing pedestrian.

- » Upgrade lighting at intersection crosswalks with medium levels of pedestrian activity (11-99 pedestrians per hour) and within crossings highly traveled by school-aged children to 30 lux (2.79 footcandles) at the following intersections:
  - Main Street and Pickett Road
  - Main Street and Fair City Mall Shopping Center Driveway
- » Upgrade lighting at intersection crosswalks across Main Street with low levels of pedestrian activity (10 or fewer pedestrians per hour) to 20 lux (1.85 footcandles) at the following intersections:

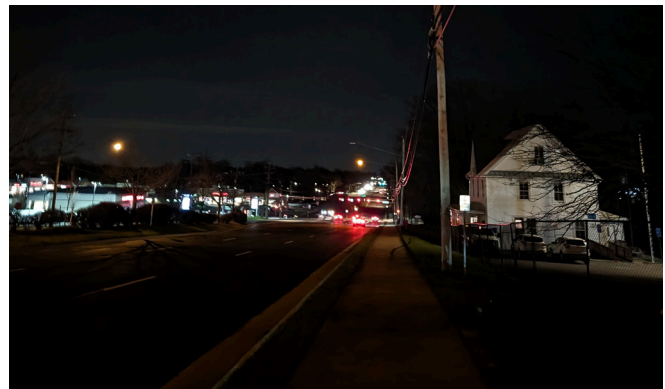
**Figure 46. Dark sidewalk on south curb of Main Street between Pickett Road and Fair City Mall Shopping Center Driveway (in front of Woodson High School)**

Lighting alongside the road and intersection corners is also generally low, with a few exceptions near businesses such as car dealerships or gas stations. **Figure 46** shows the dark conditions of the sidewalk in front of Woodson High School along Main Street between Pickett Road and the Fair City Mall Shopping Center driveway. This can reduce the ability for drivers turning onto off of Main Street to see pedestrians crossing side streets or driveways. At some locations on the corridor, lighting is placed within and between tall trees, blocked by foliage. Additionally, lighting levels also contribute to a pedestrian's perception of personal safety and security.

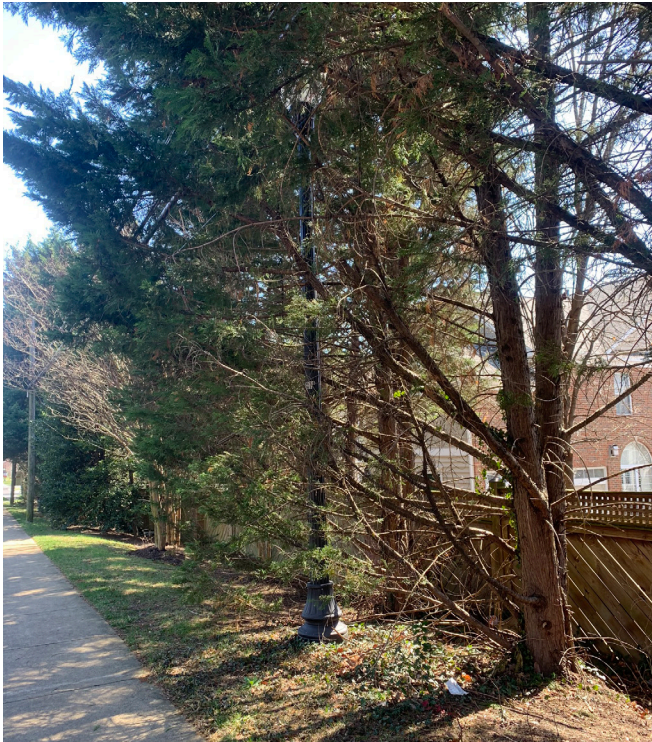
**Figure 47. Lamppost alongside south curb of Main Street between Maple Avenue and Burke Station Road blocked by trees**

During the field review it was observed that several signs along Main Street were fully or partially covered by vegetation which reduced their visibility to the roadway users. There are signs within the median which were also covered by vegetation. Additionally, a few sections of the sidewalks were also found to be covered by vegetation. **Figure 47** shows a lamppost that has been mostly surrounded by vegetation that now impacts the efficacy of the lighting.

- » Keeping the signs visible to the drivers
- » Keeping pedestrians and bicyclists visible to the drivers and vice versa
- » Increasing the line of sight for the drivers on the mainline
- » Increasing the line of sight for the drivers from side streets
- » Keeping the sidewalks clear for pedestrians
- » Maintaining illumination levels of existing street lighting

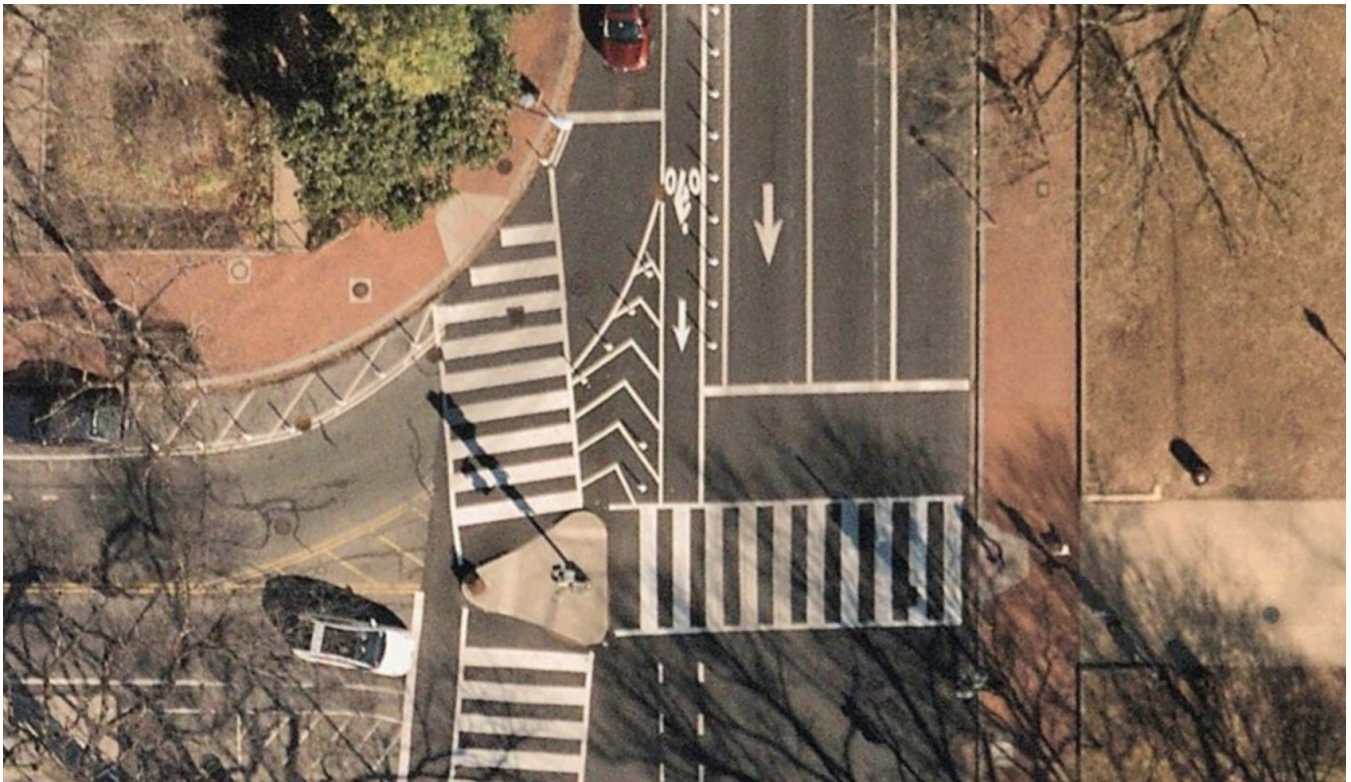
**Figure 48.** Example of curb extension with temporary materials at 11th Street and East Capitol Street in Washington, DC (Source: Nearmap)

These treatments can be installed with more permanent materials, such as concrete curbing, or with materials that are less expensive and faster to install, such as with pavement markings and raised elements like temporary curbing or flexible delineators. shows a curb extension that is created with lower-cost, faster installation materials. **Figure 48** shows an example of an intersection in Washington, D.C. with temporary curb extensions that is in the process of transitioning into hardening and curb ramp improvements.

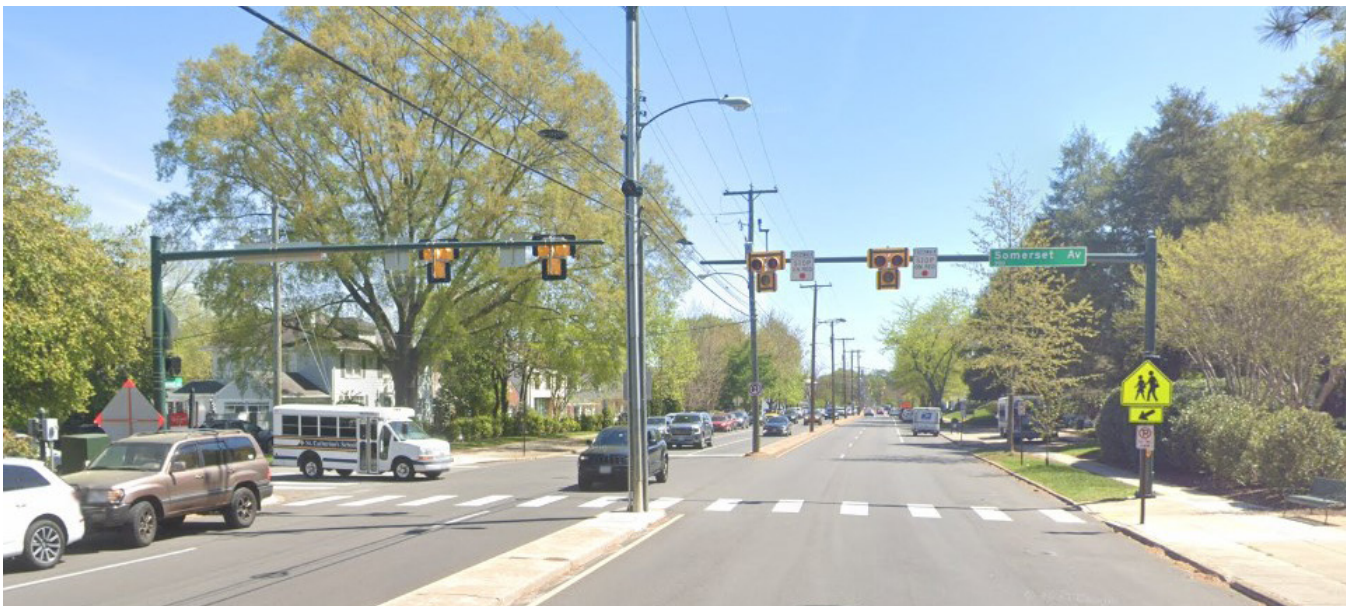
**Figure 51.** PHB at Grove Avenue at Somerset Avenue in Richmond, Virginia (Source: Google Street View)

A PHB operates as a three-light signal that is activated by a pedestrian looking to cross the street at an unsignalized crossing. Benefits of a PHB include enhanced pedestrian safety, as a red signal indication requires drivers to stop for non-motorized road users in the crosswalk. An example of a PHB in Richmond is shown in **Figure 51**. Following the red signal phase, the alternating red, or "wig-wag" indicated to drivers that they may proceed if the crosswalk is clear. PHBs can also include audible signals and tactile push buttons, which make them accessible to visually impaired individuals wanting to cross the street. Overall, the safety impact can lead to a significant crash reduction in vehicle-pedestrian crashes and total crashes. A 2010 study conducted primarily on major arterials found a 69 percent reduction in pedestrian crashes and 29 percent reduction in all crashes in locations where a PHB was installed. An additional study conducted in 2019 found that locations where PHBs had been installed had a 12 percent reduction in all crashes and a 43 percent reduction in pedestrian crashes.<sup>16</sup>

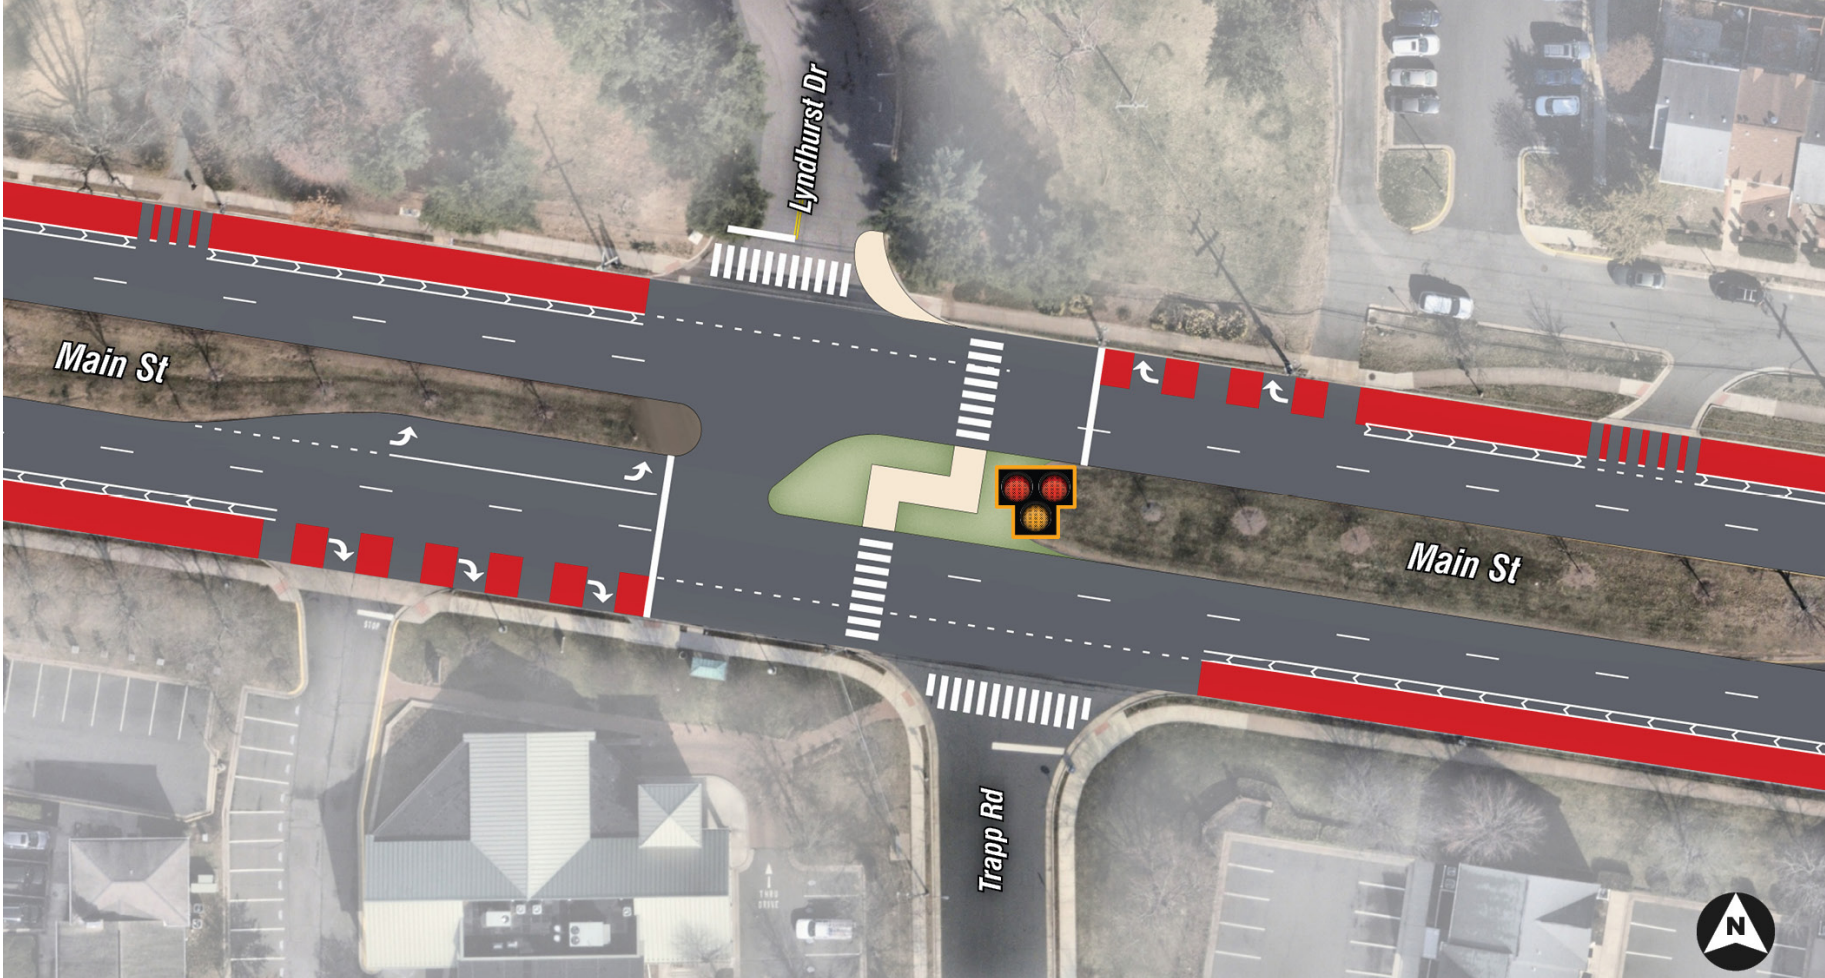
Figure 54. Potential concept for extended median on Main Street at Trapp Road / Lyndhurst Drive, relocated crosswalk, and new PHB

3. Extend the east side median nose to make Trapp Road right-in-right-out and restrict left turns from Lyndhurst Drive, relocate the existing crosswalk out of the path of vehicles turning right onto Main Street, and add a PHB.

The six-year crash history shows 33 crashes at the intersection, including one pedestrian fatal crash. Rear-end crashes are the predominant crash type followed by angle collisions which typically occur at two-way stop controlled intersections. The concepts in Figure 53, Figure 54, Figure 55, and Figure 56 below show potential safety treatments at the intersection. Note that these concepts also include the potential shared transit-bike lane to show that the proposed crossing would only be across two general purpose lanes. Design details such as crosswalk angle, curb ramps, PHB equipment placement, PHB phasing (single-stage versus two-stage crossing) and stop lines all to be determined through preliminary engineering.

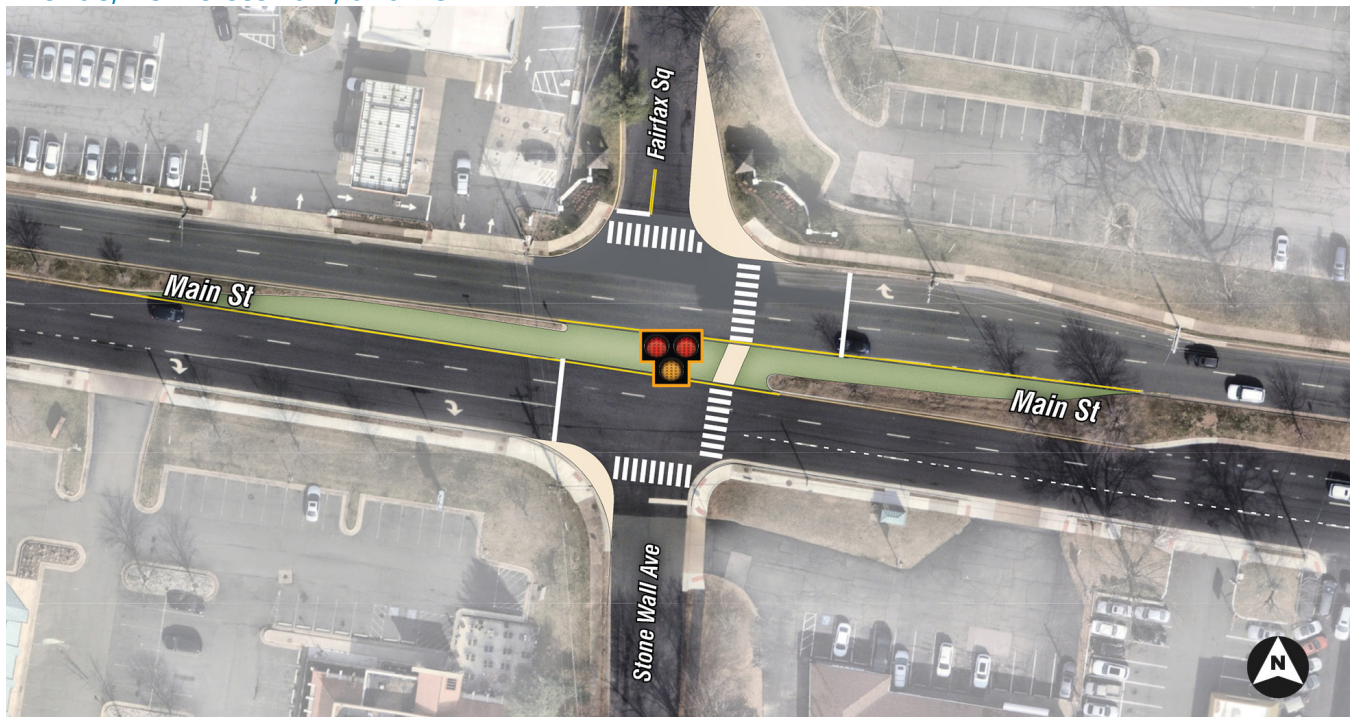
**Figure 56. Potential concept for median closure on Main Street at Fairfax Square / Stone Wall Avenue, new crosswalk, and new PHB**

One geometric design change to improve safety could be to close the median opening on Main Street at Stone Wall Avenue / Fairfax Square, which would reduce conflict points, as well as provide space for a pedestrian crossing with a refuge and equipped PHB, as shown in **Figure 56**. This alternative would also be best accompanied by a shift in the eastbound bus stop from the near side of the intersection to the far side. Design details such as crosswalk angle, curb ramps, PHB equipment placement, PHB phasing (single-stage versus two-stage crossing) and stop lines all to be determined through preliminary engineering.

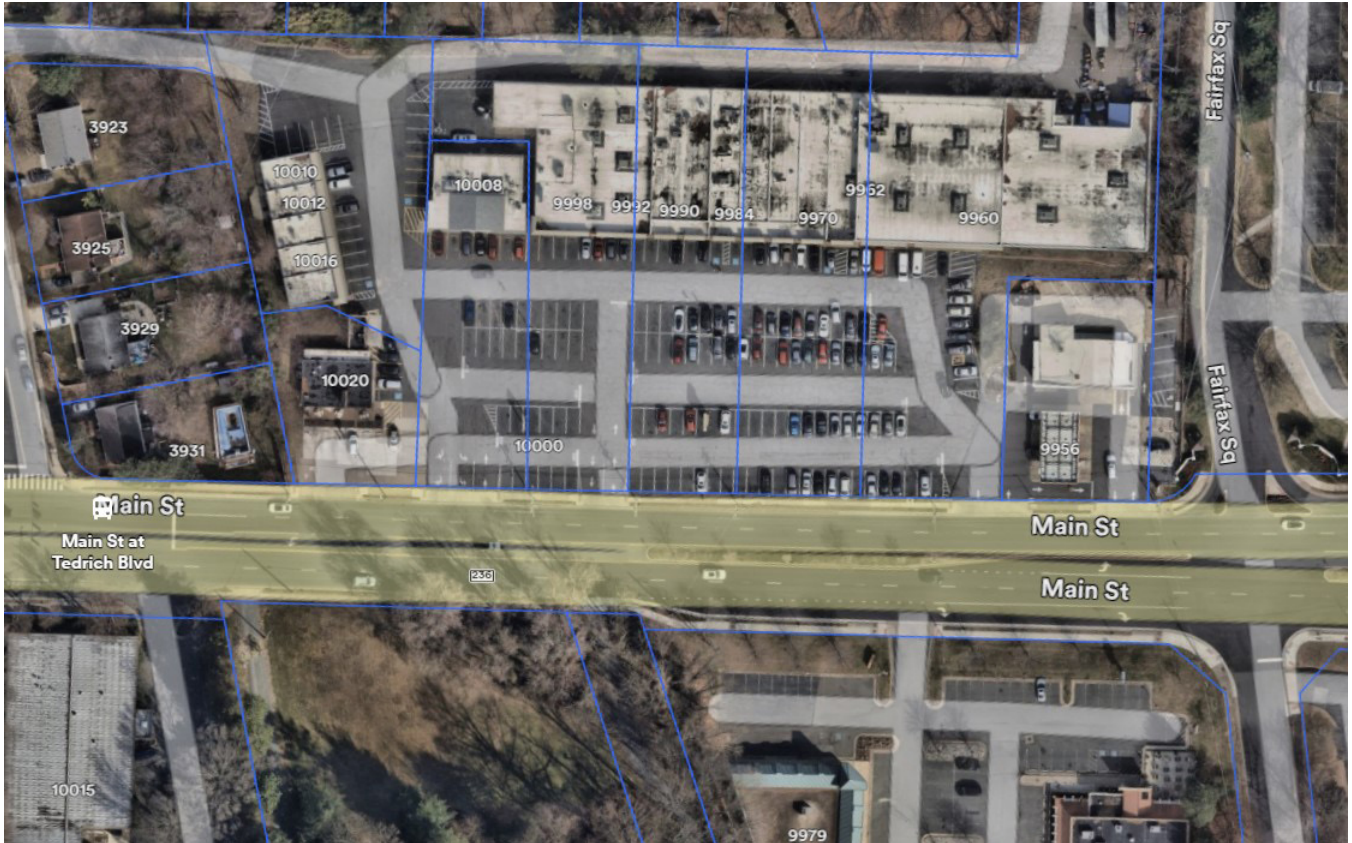
Figure 57. Parcels making up the Main Street Shopping Center between Stone Wall Avenue / Fairfax Square and Tedrich Boulevard (Source: Nearmap)

Coordination with the Main Street Shopping Center property owner(s) is needed to reduce the number of access points to the shopping center, as it is currently made up of eight total parcels, seven of which front Main Street (Figure 57).

There are several potential ways to reduce conflict points and the risk of angle crashes on Main Street in front of the Main Street Shopping Center between Tedrich Boulevard and Stone Wall Avenue. One could include the reduction and consolidation of driveways/ access points on Main Street in this crash hotspot. The reduction of access points could reduce the risk of angle crashes for those vehicles turning left from driveways, rear end crashes for those entering Main Street, and reduce the additional driver attention required to react to turning vehicles on this block. Given the close spacing of driveways, drivers may not know which driveway the vehicle in front of them may be accessing when indicating a turn (if a turn signal is used). This uncertainty can be lessened by reducing the number of potential driveways closely spaced along the corridor. Studies have found that changing an existing two-way left turn lane to a raised median can have a potential crash reduction of 23 percent.<sup>19</sup> Additionally, changing an access point to right-in-right-out can have a potential crash reduction of 45 percent.<sup>20</sup> Conducting an HSM safety analysis can help determine the potential safety benefit of improvements, and combination of improvements, within the impacted area.

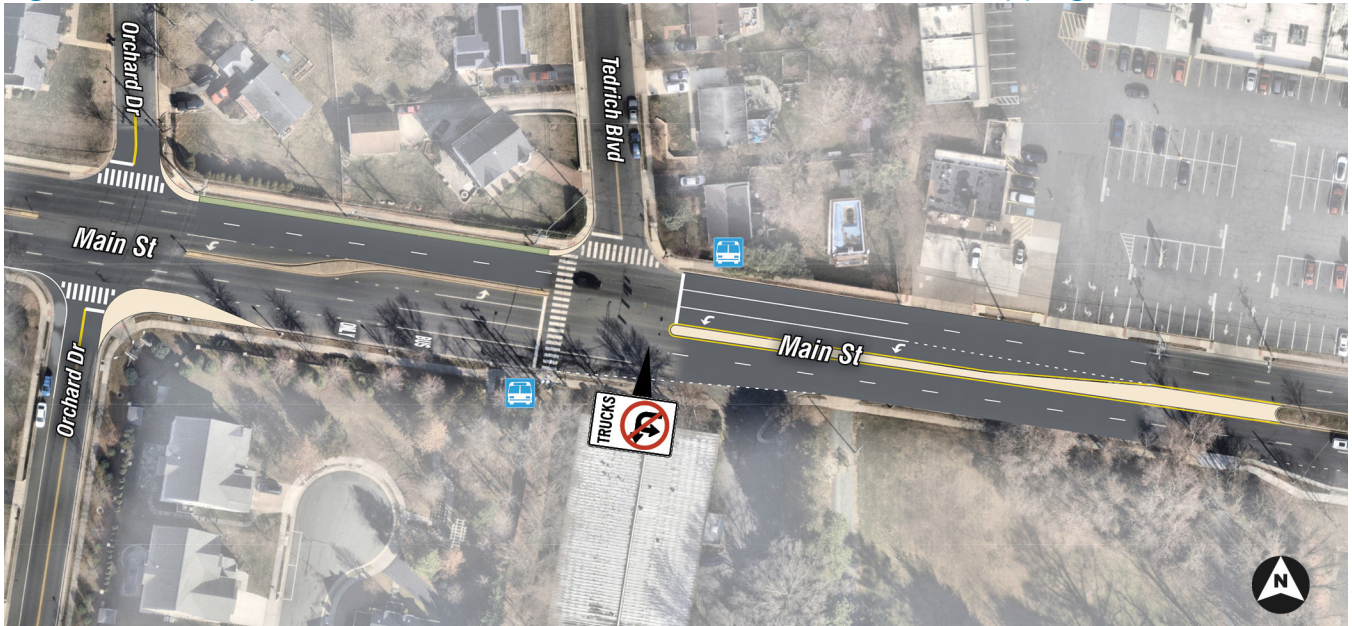
Figure 58. Concept for median closure in front of the Main Street Shopping Center

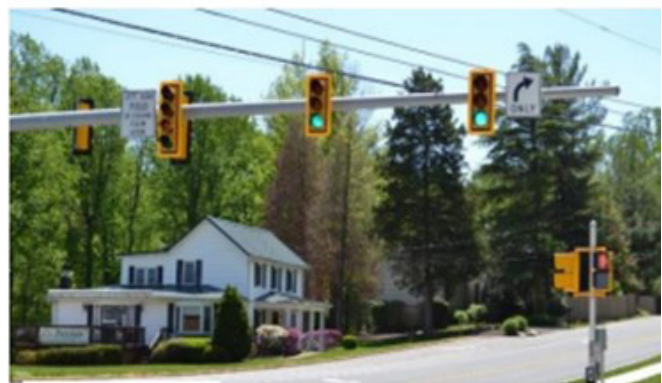
Figure 59. An Example of a High Visibility Backplates in Virginia

High visibility signal backplates are a potential safety countermeasure that could be implemented for all signal heads at intersections along Main Street. High visibility backplates are backplates with retroreflective borders that provide enhanced signal visibility.

*High visibility signal backplates in Virginia.*

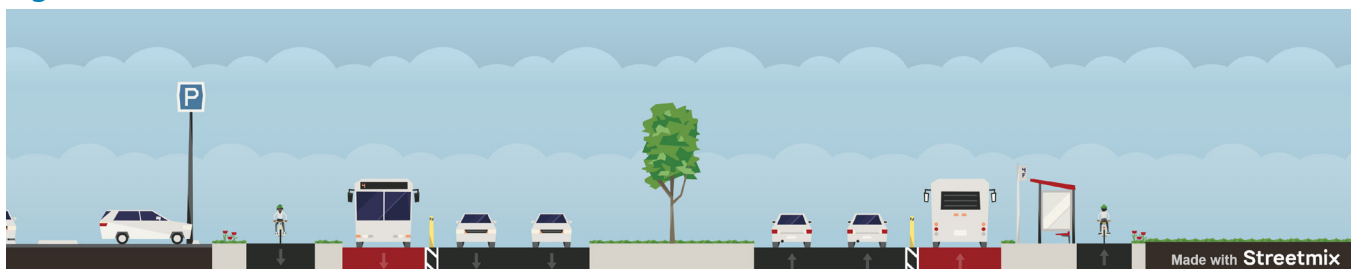
**Figure 61.** Potential Main Street cross-section between Whitacre Road and Estel Road

The transition to the new cross-section west of Estel Road will also need to be considered, as the shared-use paths on either side would transition into one-way bike lanes. This means that if bicyclists are using the shared-use path in the opposite direction of travel (i.e. traveling eastbound on the north side of Main Street), bicyclists would need to cross Main Street in order to travel in the correct direction of the bike lane. Such crossing would be best at an intersection location where drivers may already be expecting non-motorized crossings. The nearest marked crossing point to Estel Road is the intersection of Lyndhurst Drive / Trapp Road, which could provide a bike crossing with a potential PHB.

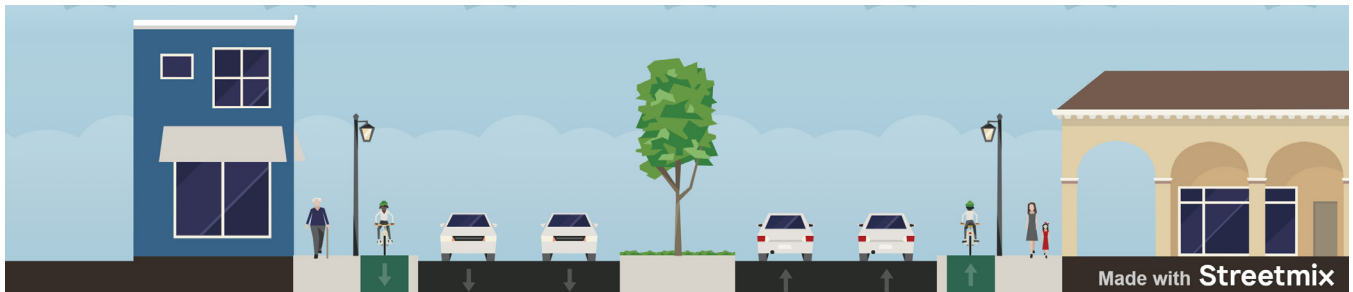
**Figure 63. Potential Main Street cross-section between Stone Wall Avenue / Fairfax Square and East Street / Blenheim Boulevard**
