Multimodal Coordination for Bus Priority Hotspots

Task 3 Technical Memorandum: Field Verification of Hotspots

Prepared for the National Capital Region Transportation Planning Board (TPB)

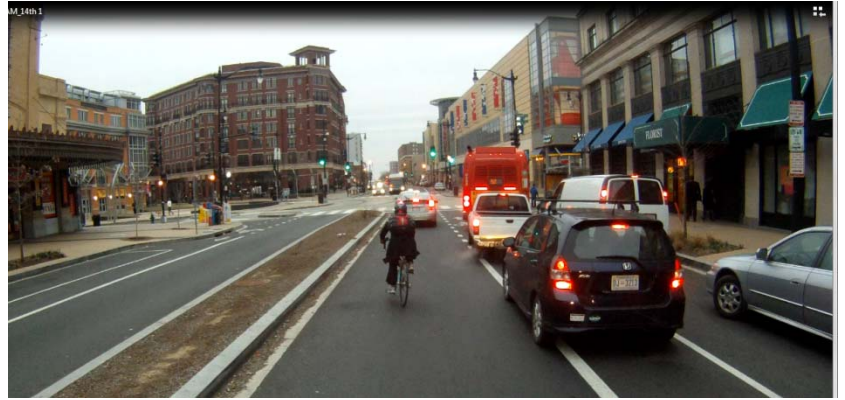
This segment of roadway is a primary north-south arterial from the Central Business District up through Columbia Heights. The roadway cross section changes from a two-lane section north of Park Road, a three-lane section between Harvard Street and Park Road, and a four-lane section south of Harvard Street. Full-time on-street parking is

Figure 2: Southbound 14th Street Approaching Park Road

In the northbound direction in the PM peak hour, traffic congestion was observed northbound between Harvard Street and Kenyon Street/ Park Road, and in the AM southbound between Park Road and Otis Place. In these stretches, it was observed that most vehicles including buses required several traffic signal cycles to clear the intersection thus resulting in slow travel speeds. Outside of this segment no vehicle congestion was observed in either peak hour.

- Remove the bike lanes and install a bus only lane in one direction from Irving Street to Logan Circle (all or part).** This option could provide a dedicated transit lane in one direction along 14th Street. Bicycles could share the lane in one direction but would no longer have dedicated space to ride in the other direction. This option is likely to meet significant resistance from the bicycling community. However, this recommendation is put forward for consideration under the supposition that the 15th Street cycle track may be able to absorb some of the cycling traffic south of V Street. Bicycle traffic volumes for both streets will need to be reviewed. The configuration of travel lanes for autos under this scenario would remain unchanged.

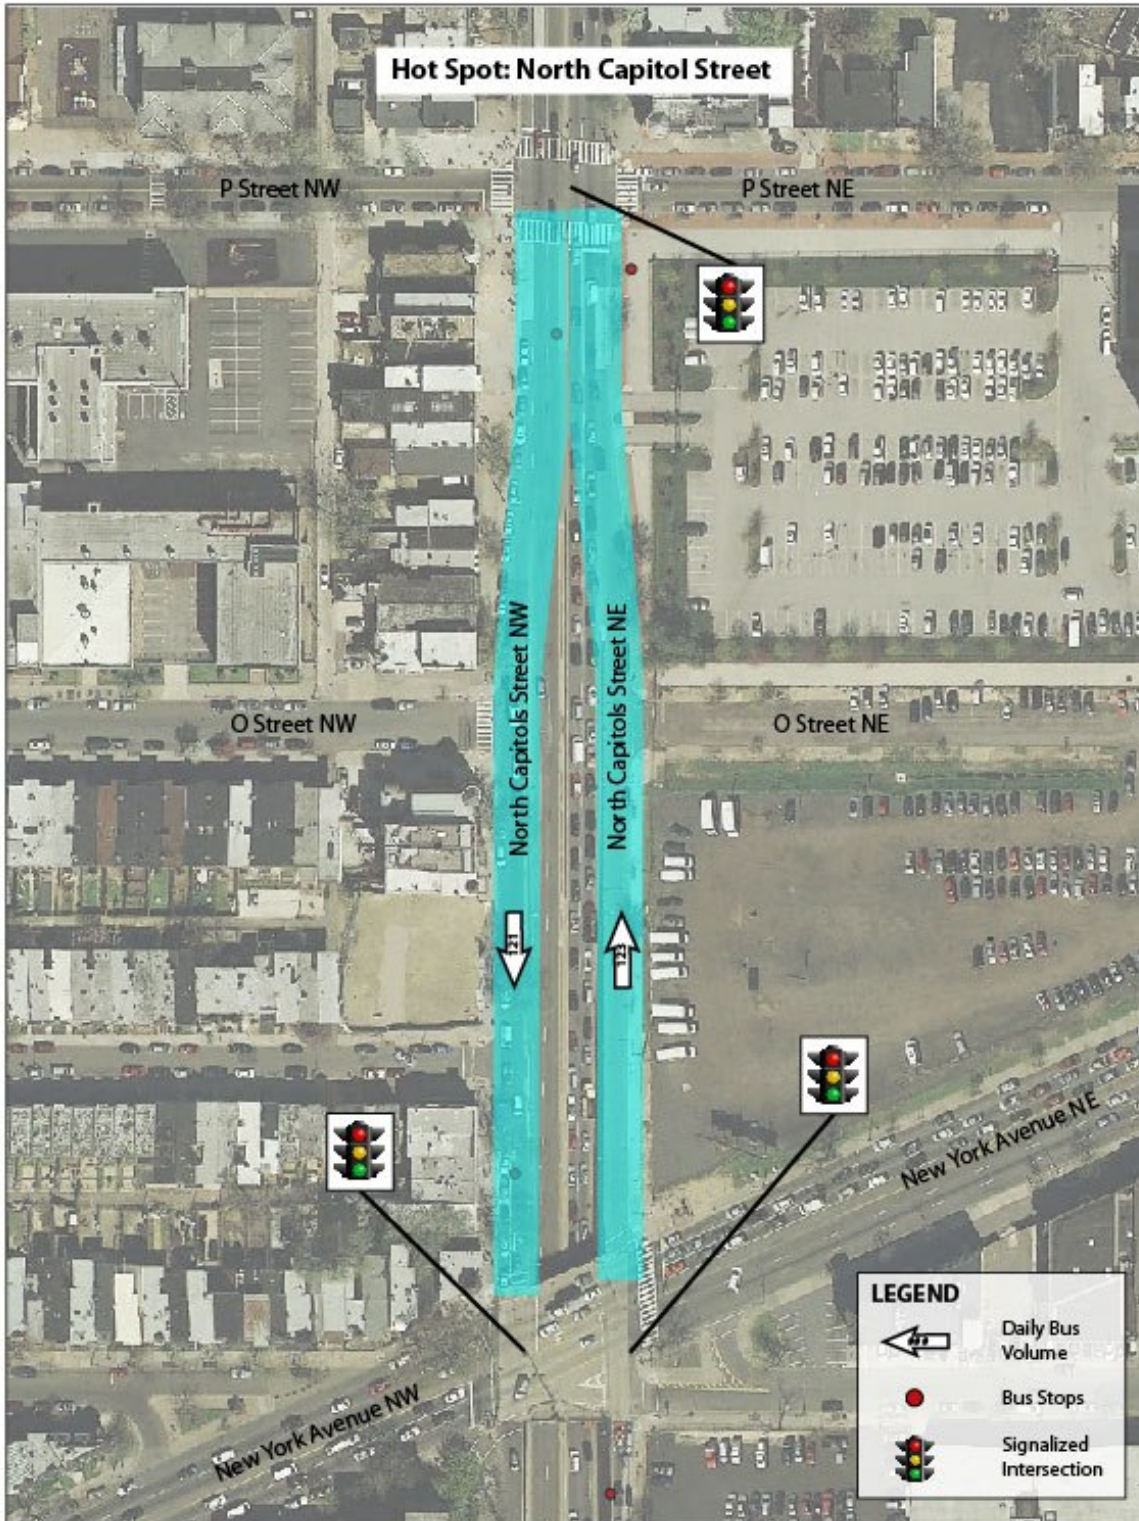
Figure 4: Detail of the North Capitol Street hot spot

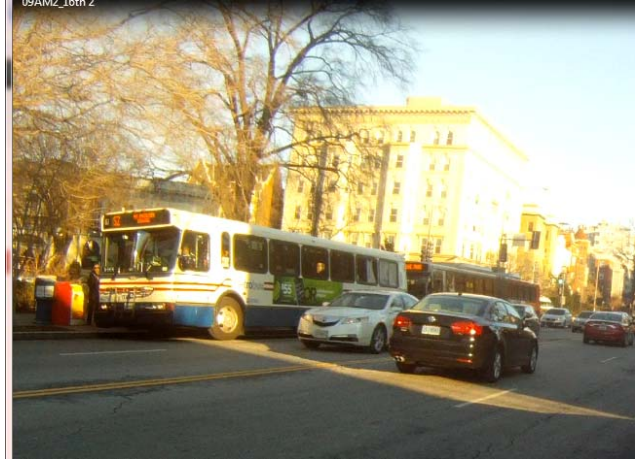
Figure 5: Bus Bunching on SB 16th Street at U Street

Significant bus bunching was noted for Metrobus routes S1 & S2, with observed headways of less than five minutes. Ridership on all buses was observed to be very high – standing room only on most buses. Boarding activity on bus stops in the northern portion of the corridor near Park and Irving, as well as near Columbia Road, Euclid and U Street were very high – up to 35+ persons. Some passengers were not able to board when buses stopped. Other buses that were full were observed to skip stops. When multiple buses arrived at a stop at the same time, there was often not enough curb space for them to fit to allow passengers to conveniently alight and board. Lastly, many bus stops were near side which also created additional delays.

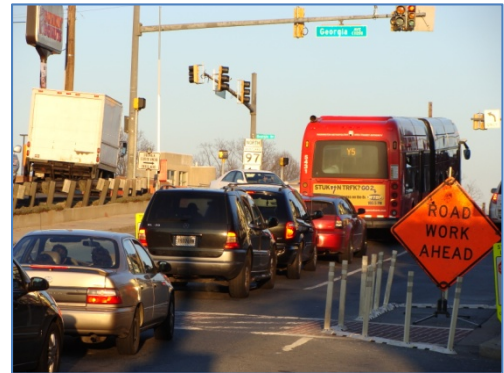
crosswalk is heavily signed with pavement striping and bollards, but does not have a pedestrian crossing signal. As a result, pedestrians cross at random intervals that are not in synch with the signals at Georgia Avenue or Veirs Mill Road. Traffic is very accommodating, but the result is queues emanating from this mid-block location. Curbside parking further constrains the roadway and slows traffic speeds, leading to more missed signal phases by buses. Lastly, the left turn phase from Reedie onto Veirs Mill is frequently inhibited by conflicts with pedestrians crossing Veirs Mill Road, causing vehicles to miss signal phases and queues to form WB.

Figure 7: Traffic Queues on Reedie Drive EB

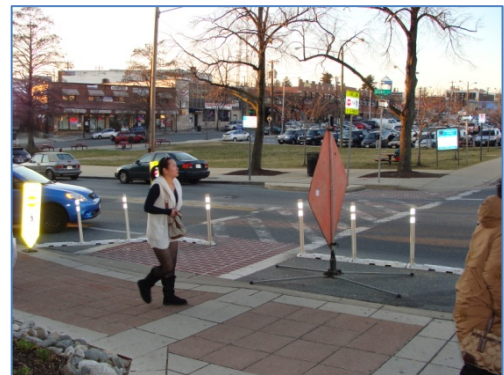
Figure 8: Highly Protected Pedestrian Crossing of Reedie Drive at Triangle Lane

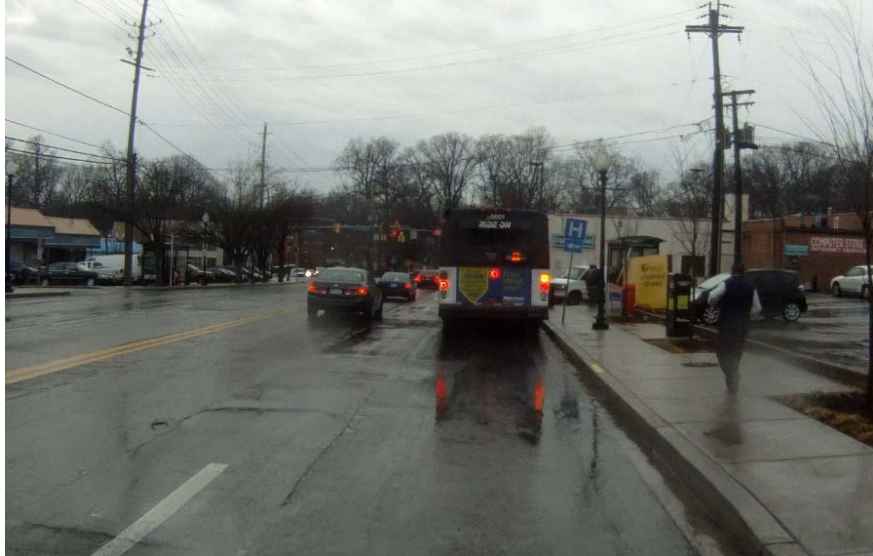
A significant investment in bus stop amenities has recently been made in this corridor including concrete landing pads, shelters, lighting, benches and trash receptacles. However, the bus stop locations are fairly dense – in some segments near Baron, Park Crest and Devon Streets stops are located on every block to serve adjacent apartment complexes. In addition, many of these stops are

Figure 10: Mid-block Bus Stop along Piney Branch

near-side which could result in buses stopping twice. Bus bunching was observed in the PM peak hour on the Ride On #15 and 16 routes. However, bus stop activity was moderate to light (less than five person) throughout most of the time observed.

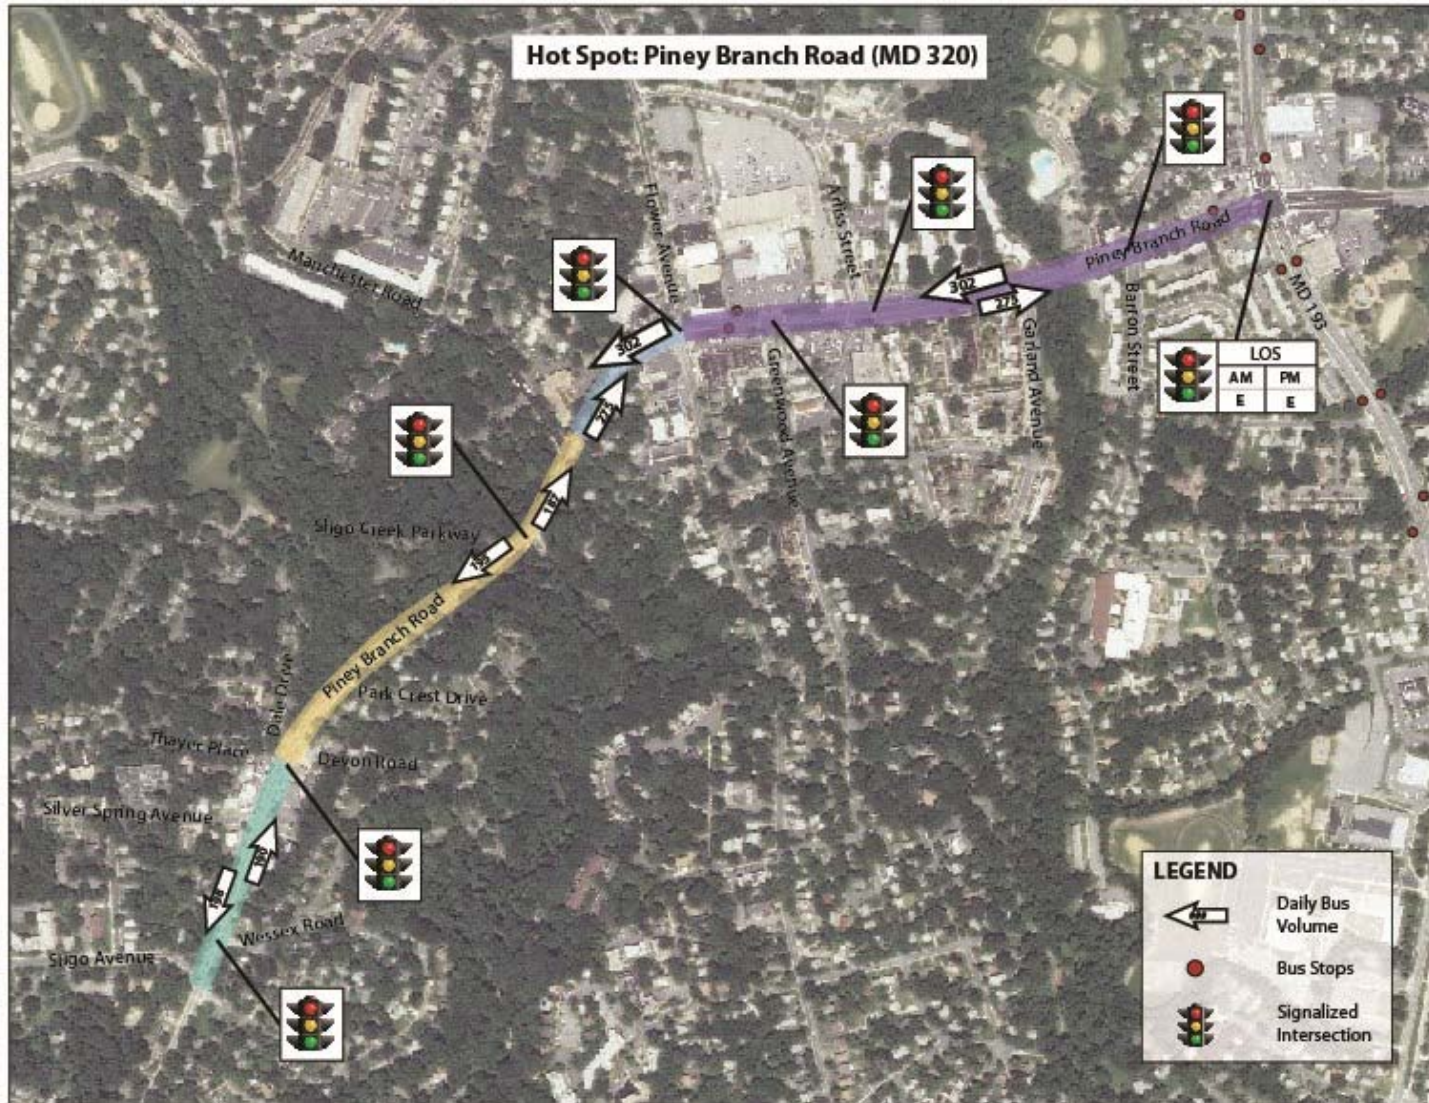
Figure 11: Detail of Piney Branch Hotspot

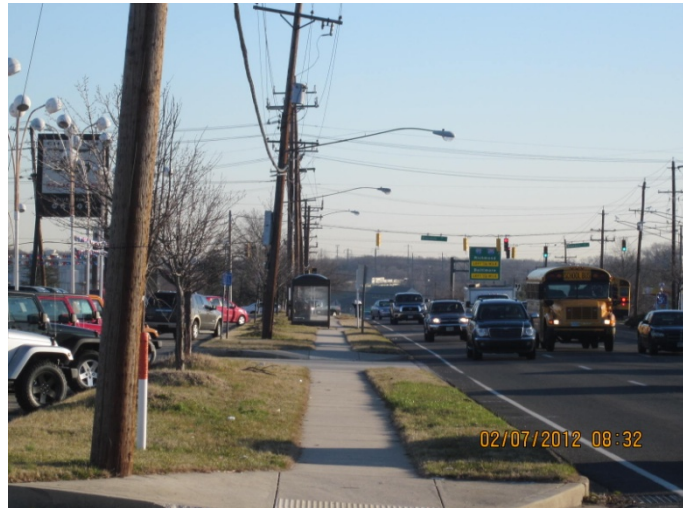
Figure 12: Mid-block Bus Stop on Annapolis Road

A major problem observed was the proliferation of bus stops along this section of roadway, three in each direction. The two stops at the east end of the segment were very close to one another. There was an observed hazard situation associated with bus stop users (and pedestrians in general) crossing Annapolis Road mid-block, with only a four-foot median island in the roadway to provide protection. There are also old pedestrian signals at the Riverdale Road intersection.

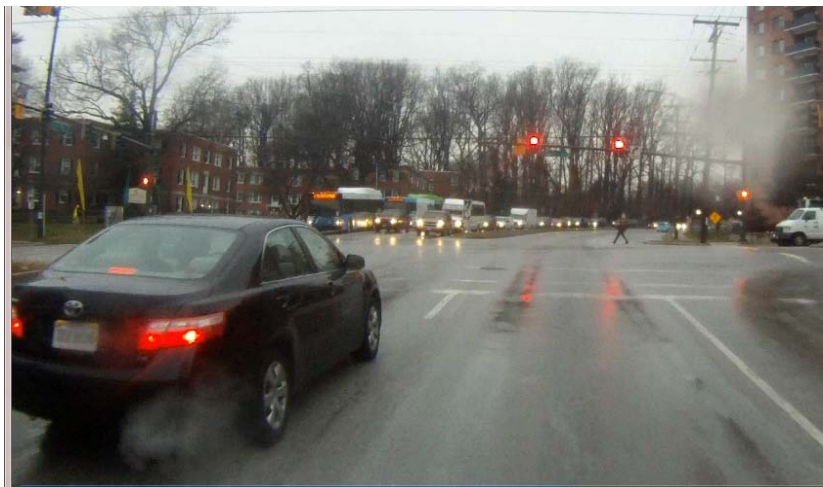
The J3 and J1 Metrobus buses were full with standing room only in the eastbound

Figure 14: Bus Bunching on EB East-West Highway Approaching Colesville Road

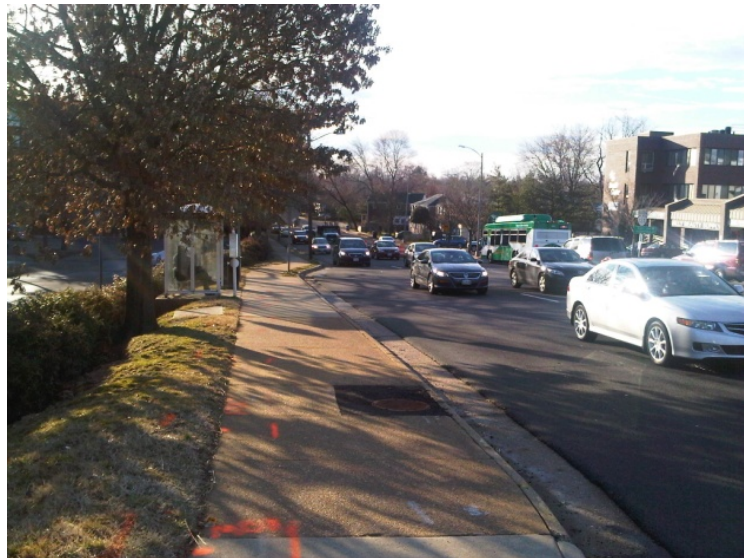
- The bus stop on EB Arlington Blvd is located to the east of the interchange, on a narrow strip of grass between the main line and the ramp from NB Glebe Rd. This stop is not equipped with a sidewalk/waiting pad or a shelter, and is in a very unprotected location that is inhospitable to transit passengers. There is also no paved or ADA accessible path connecting to

Figure 17: Existing Bus Pull-out on NB Glebe Rd

the surrounding sidewalk network, creating a safety hazard for all users, but particularly for those with disabilities.

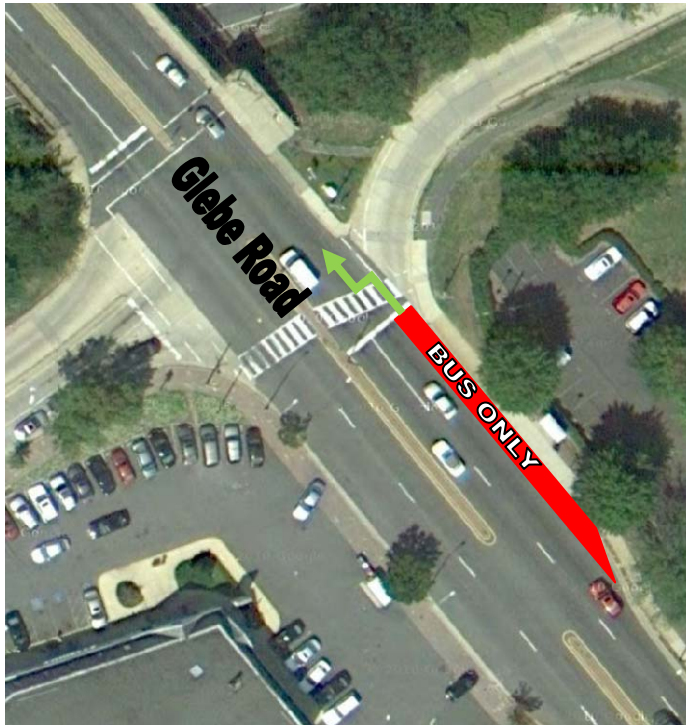
Figure 18: Potential Configuration for Queue Jump on NB Glebe Road

indicates that the ongoing construction project observed at this location will widen the bridge over Arlington Blvd to accommodate a left-turn lane from NB Glebe Rd to WB Arlington Blvd. This should help to alleviate some of the congestion created by the current left-turn traffic queuing in the shared through/left-turn lane.
