Carroll County Maryland's Regional Stormwater Management Strategy

COG Workshop

Martin B. Covington, III, PE

Modified, Enhanced, and Enlarged Sand Filters as
Retrofits of Existing Stormwater Management Ponds

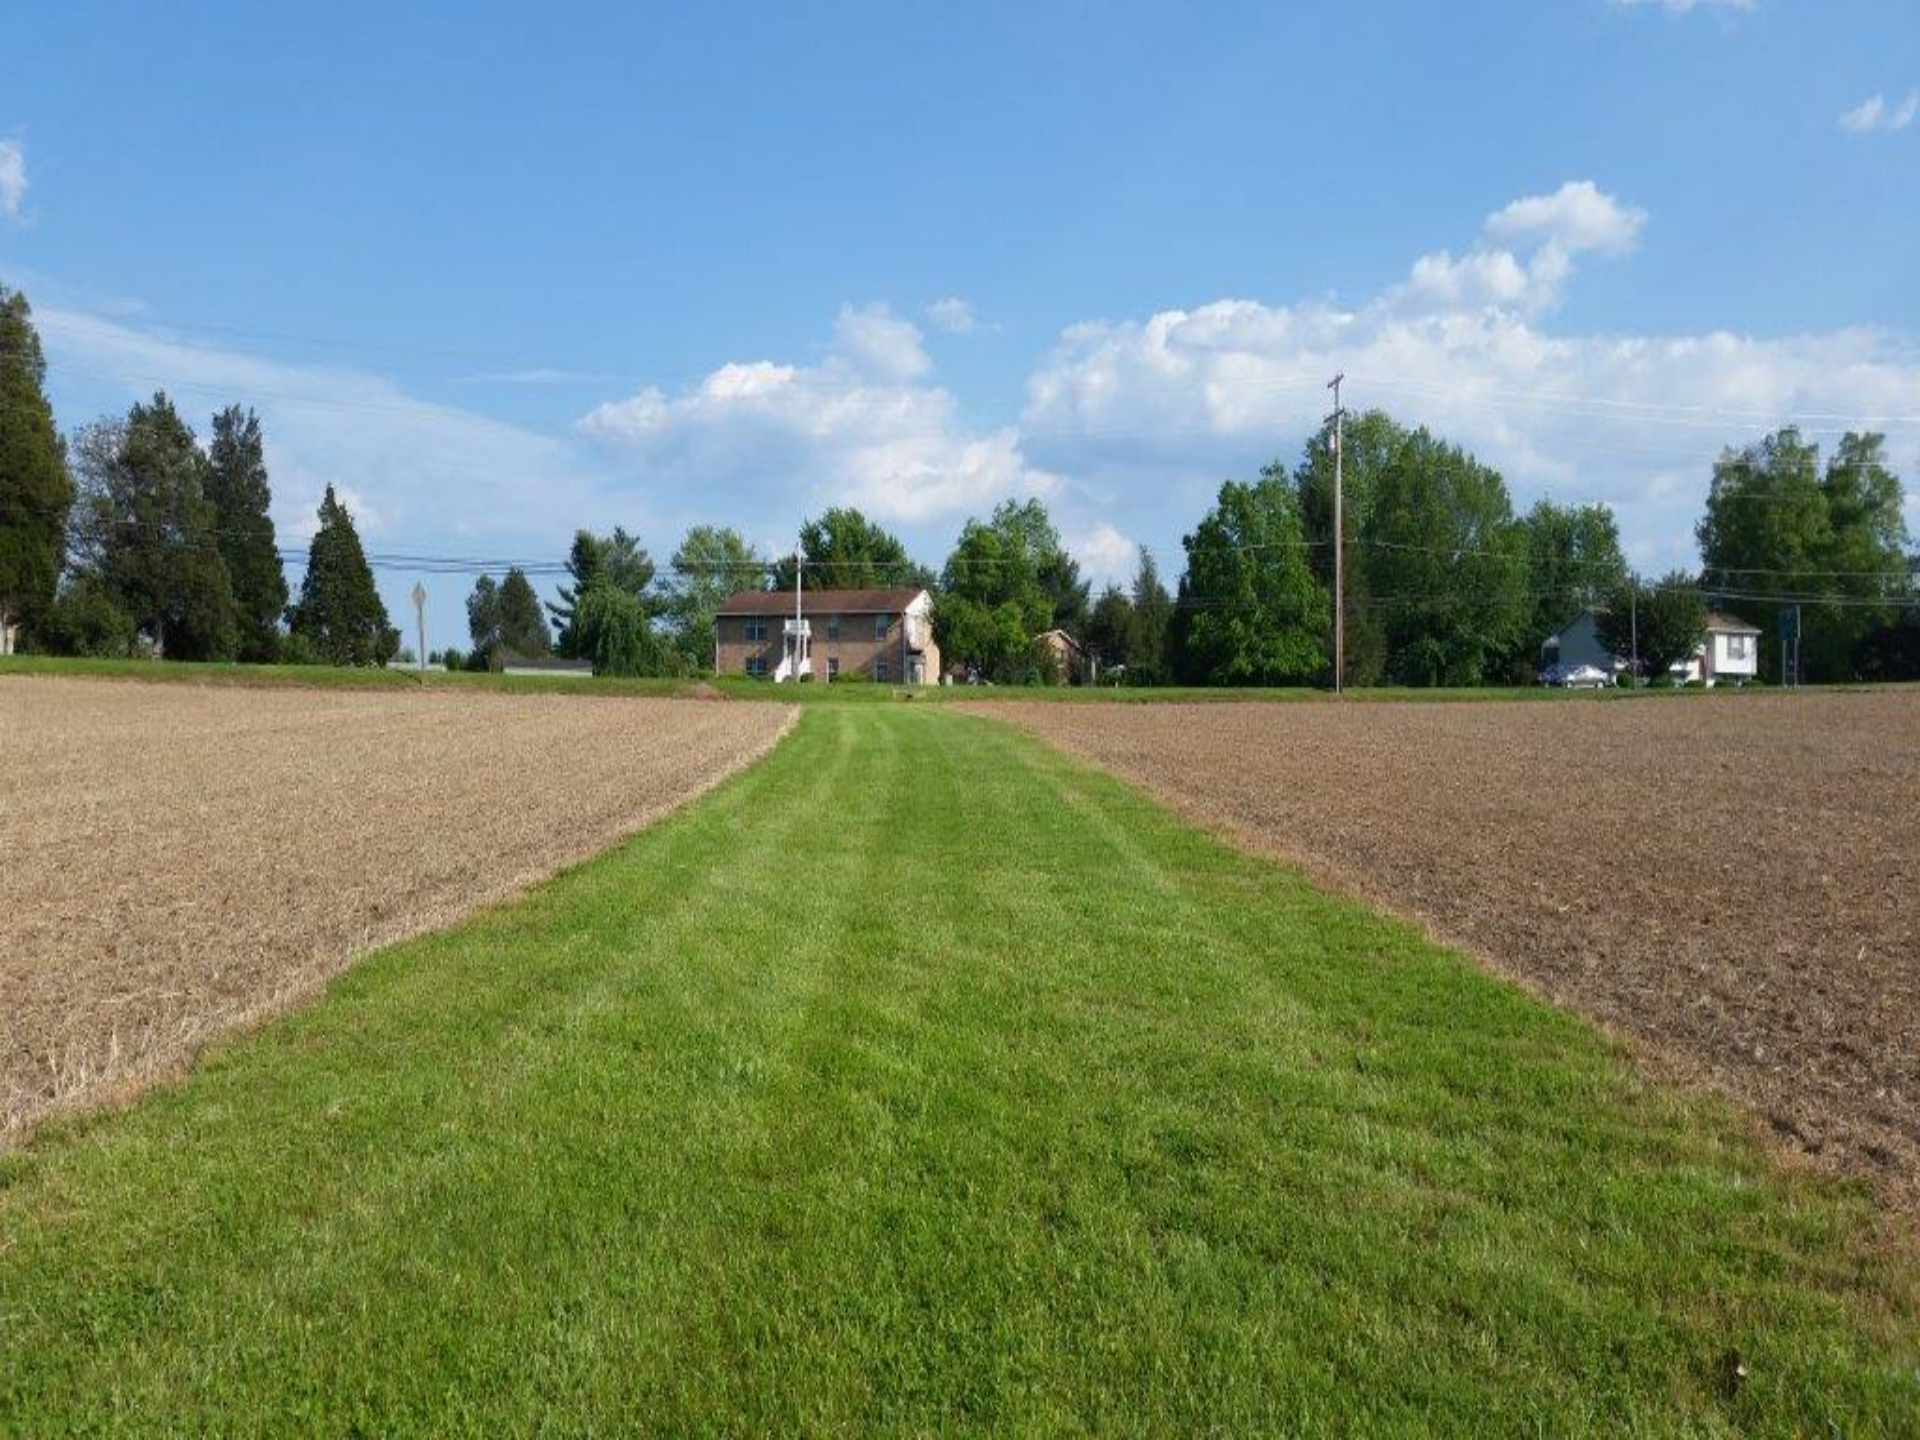
- Myron Frock (who had worked with S.C.S. for many years) pointed out that grassed waterways used in agriculture to prevent soil erosion in fields also proved remarkably effective at filtering the water, particularly when underlain with drain “tile.”
- The typical agricultural waterway consists of a perforated HDPE pipe surrounded by 4-inches to 6-inches of stone and overlain by sod.

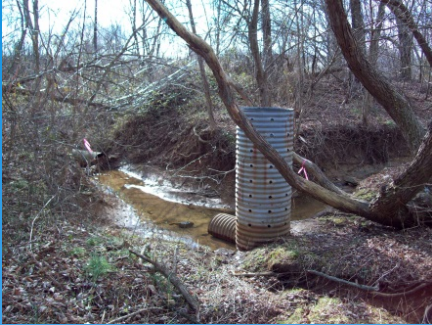
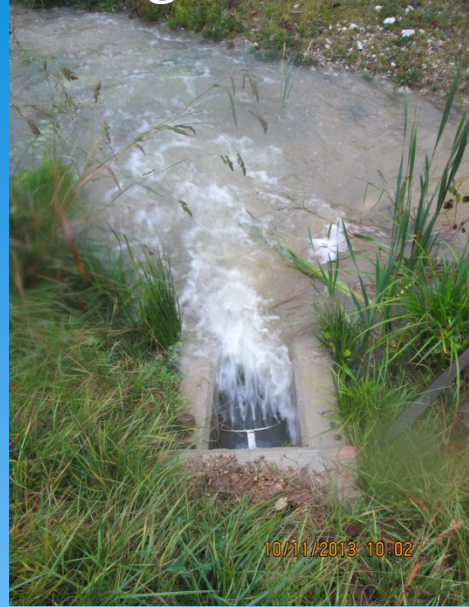
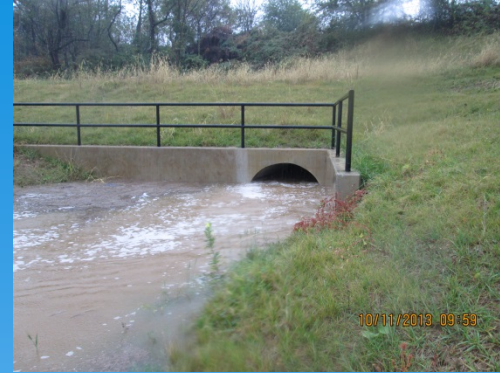
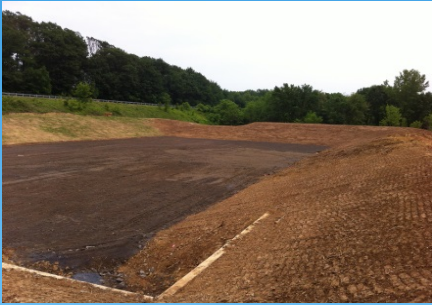
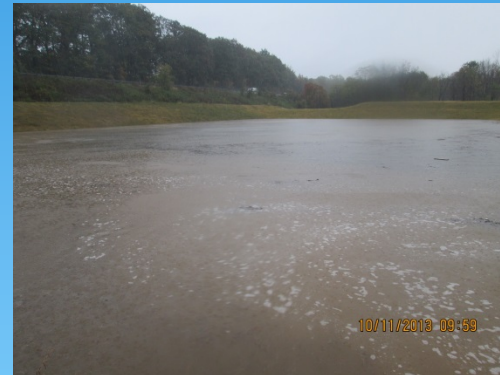
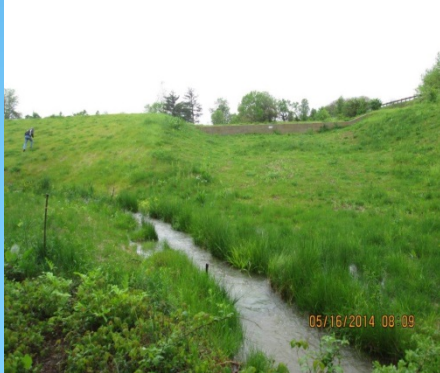
Westminster High School Pond Retrofit

DA - 115 acres IA - 42 acres
Volume to Spillway 3.4"/IA

ST Practice	RR Practice
TN	601 lbs/year	781 tons/year
TP	67 lbs/year	80 tons/year
TSS	20 tons/year	21.5 tons/year

Constructed in 2013
Cost \$1,100,00
\$26,000/IA

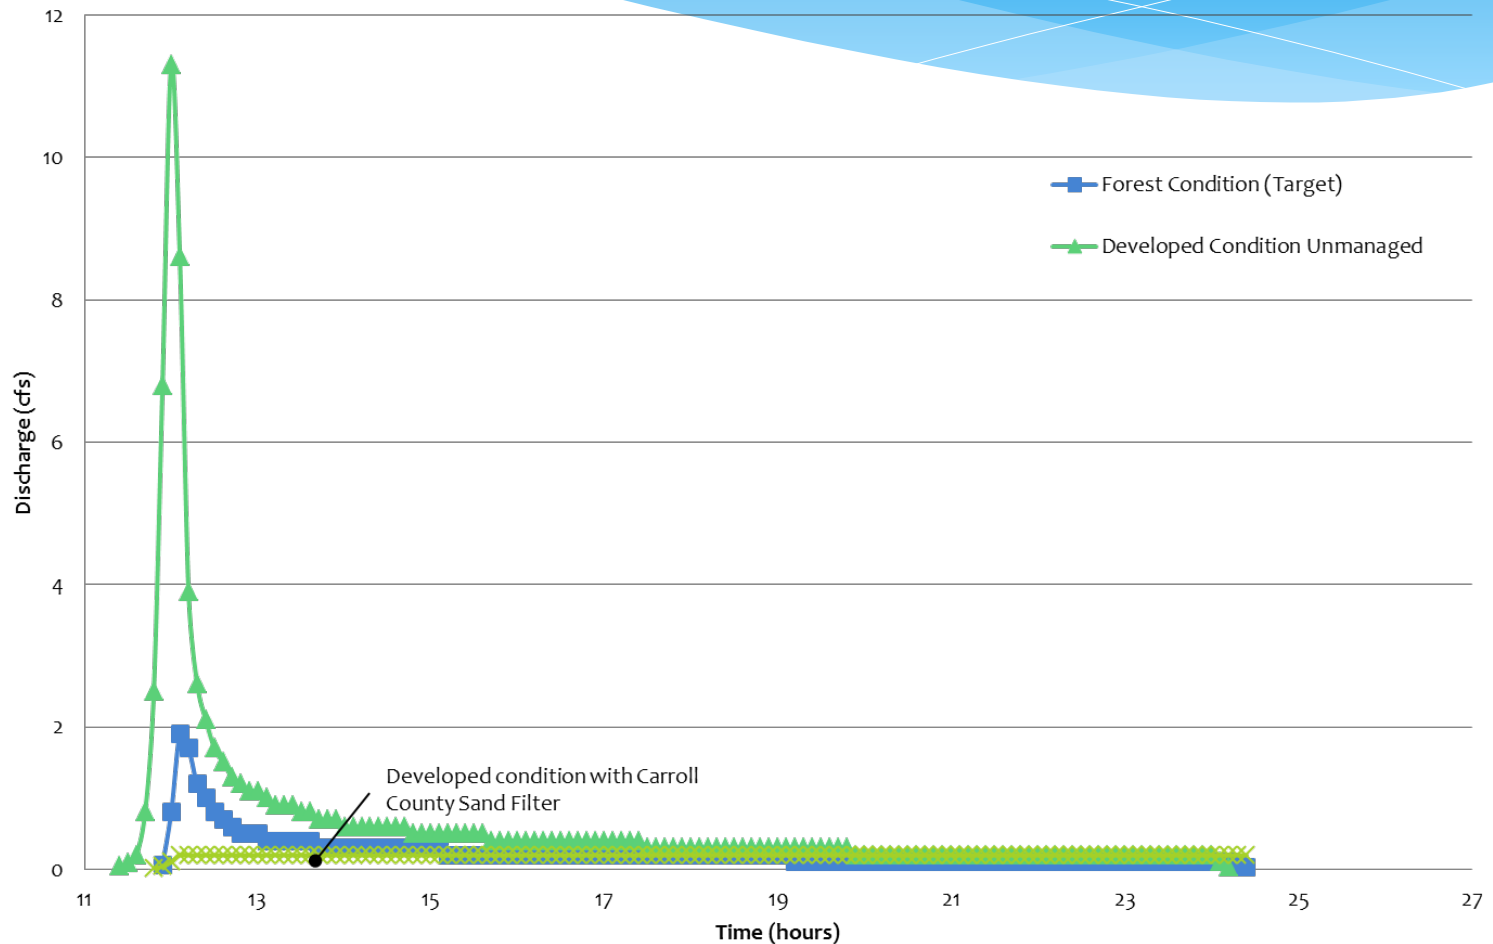
Figure 5

2 Year Storm Runoff - 10 Acre - B Soil
Forest vs 30% Impervious (Developed) Unmanaged & Managed

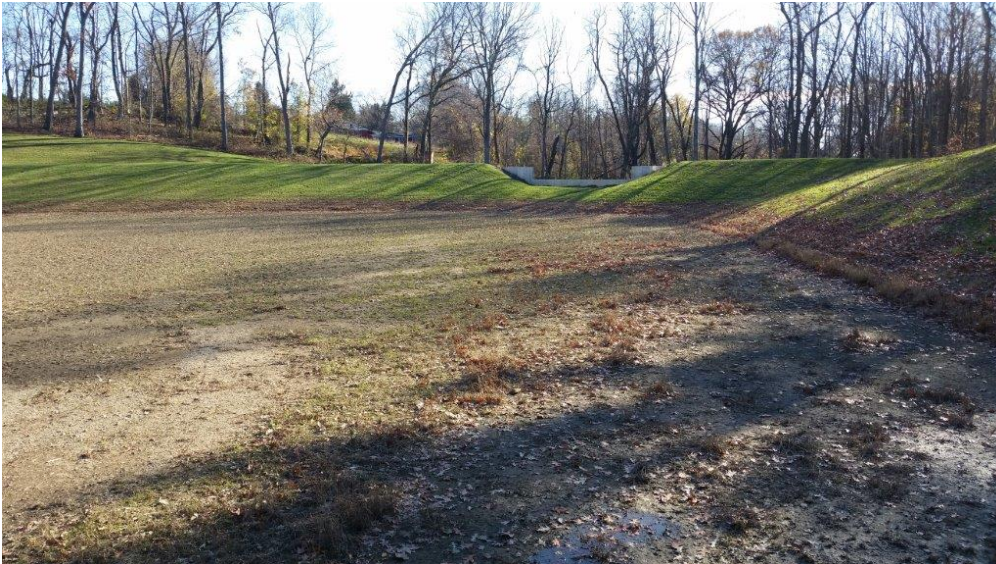
In dam, stand alone weir walls, at 10 year WSEL able to pass the 100 year storm safely

Retrofit Problem/Emergency Spillway

1. Must be in undisturbed “virgin” ground, not dam fill
2. But the undisturbed land and ends of dam are not on the parcel

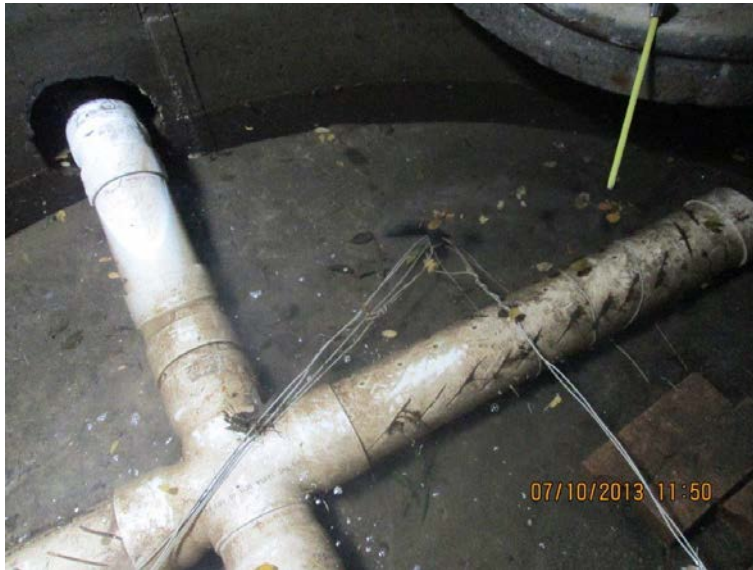
Bypass base flow from drop structure

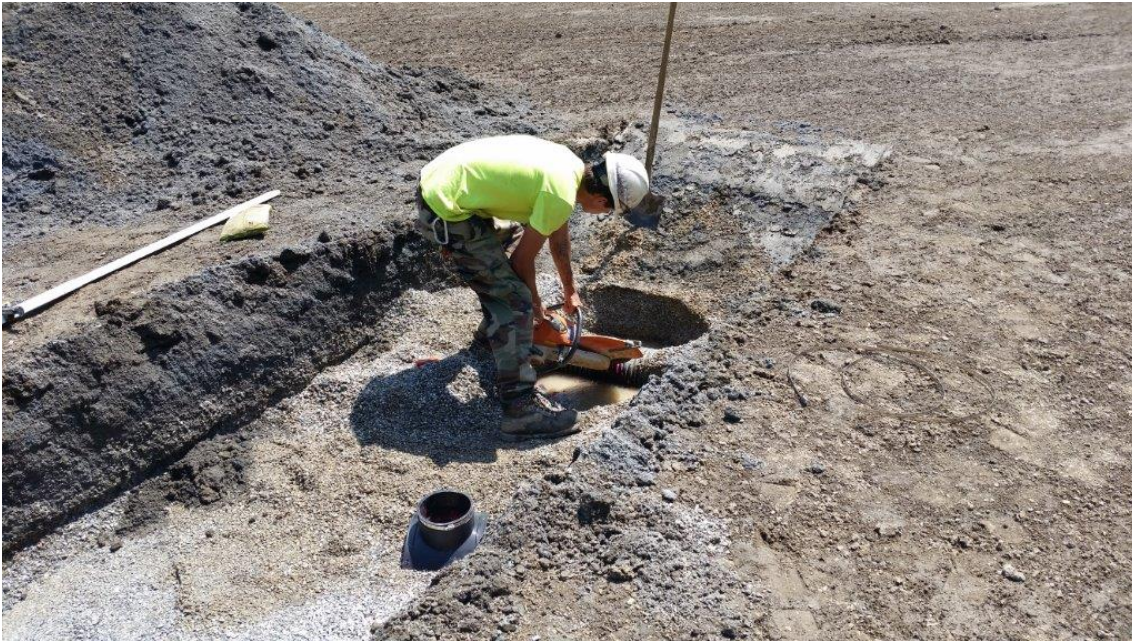
Add more underdrain
pipes
