SAV Status & Trends

13 Nov 2017

Water Quality Goal Implementation Team

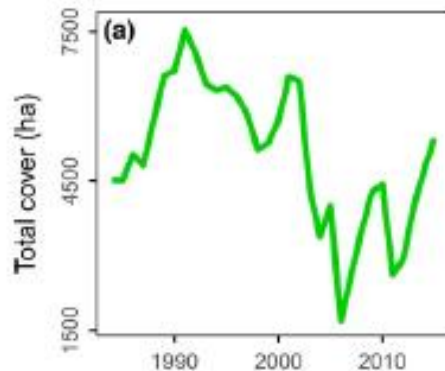
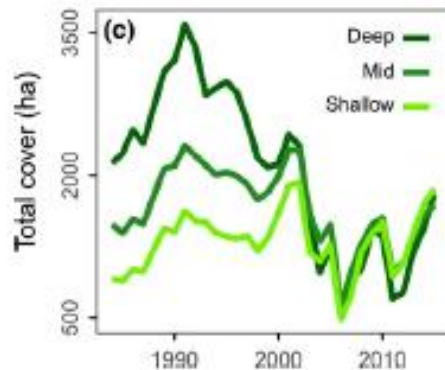
Shrinking eelgrass distribution

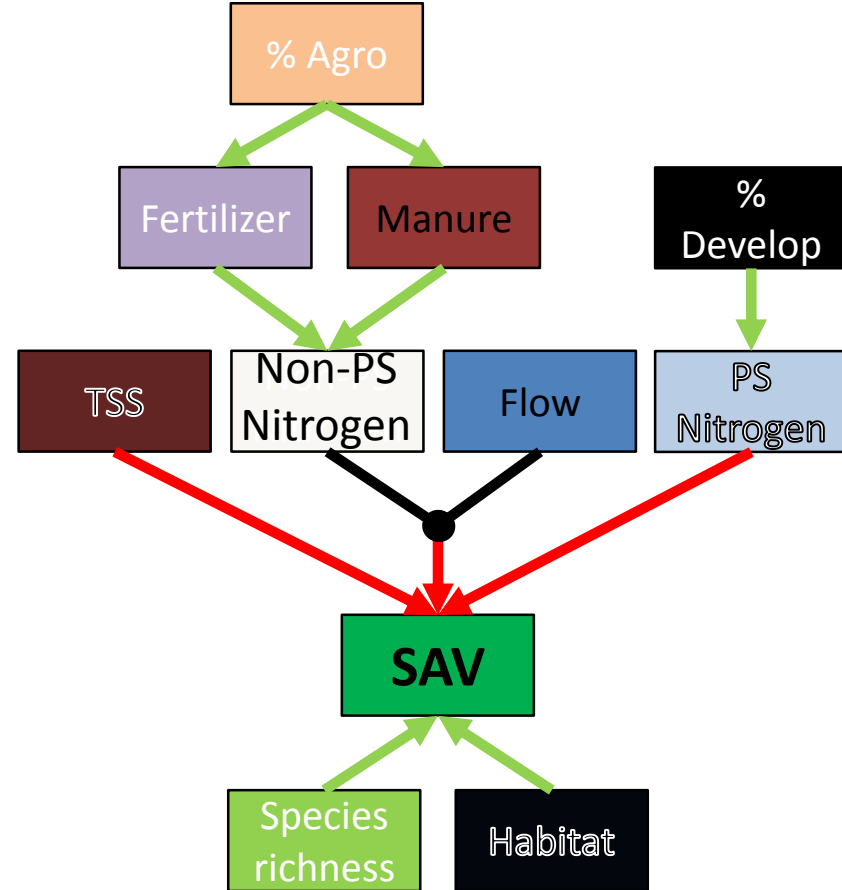
Hypothesized SEM

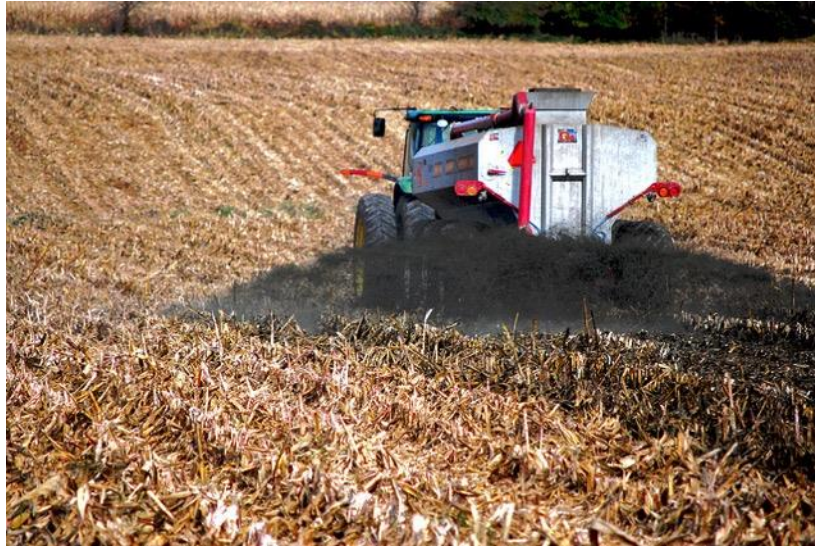
Watershed SEM

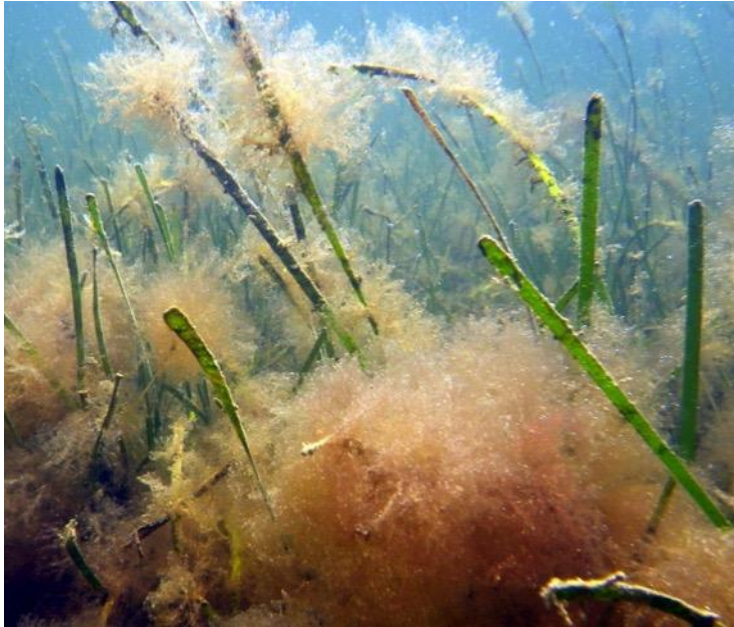
Water column SEM

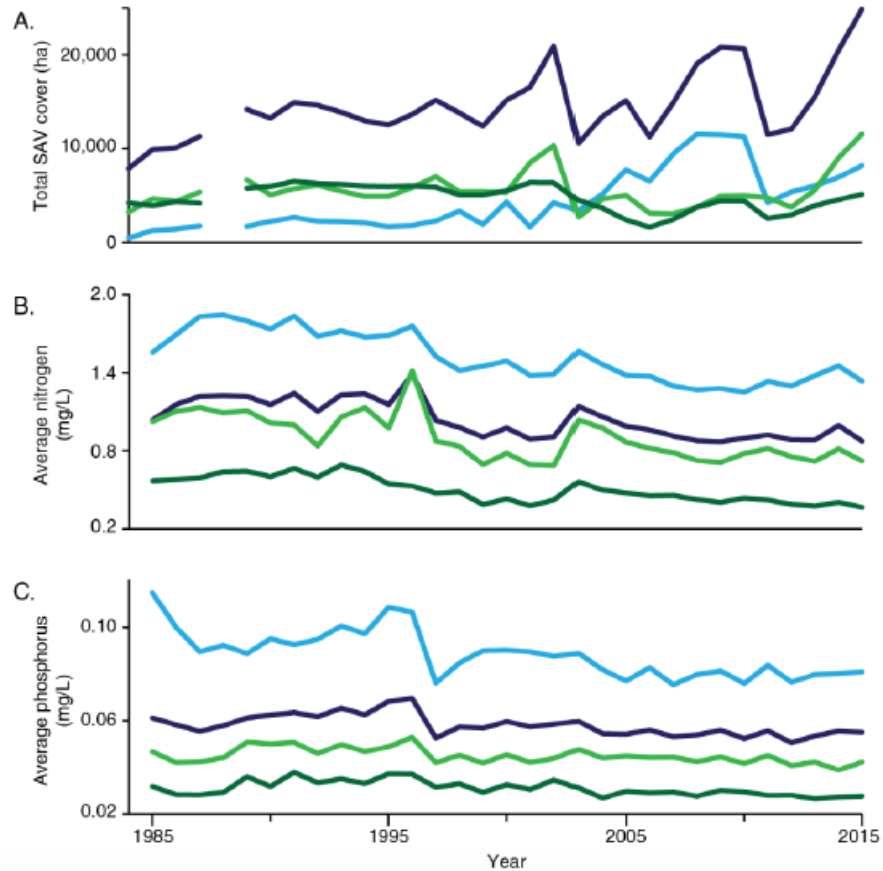
SAV increase & N and P decrease
