POTOMAC RIVER WATER QUALITY IN THE METROPOLITAN WASHINGTON REGION - **DRAFT**

POTOMAC RIVER WATER QUALITY IN THE WASHINGTON REGION

Prepared by the Water Resources Technical Committee

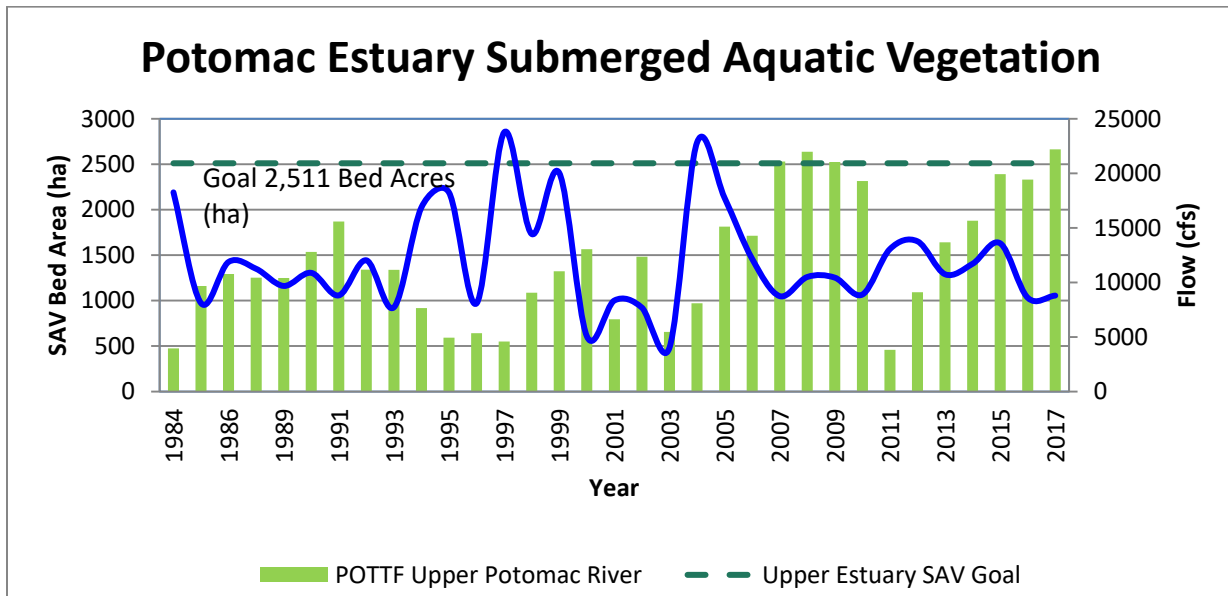
Figure 19: Potomac Estuary SAV (Upper Portion) and Flow at Chain Bridge

plants in the Washington region. These improvements show up most clearly in the freshwater portion of the Potomac estuary, which stretches from the river's fall line at Chain Bridge in Washington, D.C., downriver to the mouth of Mattawoman Creek. (See Figure 18.)

The amount of SAV growing in the upper estuary fluctuates annually because of changes in weather conditions and other factors, but overall it has increased significantly in recent years as nutrient levels in the water have decreased. Fewer nutrients tends to lead to less algal growth, which in turn increases the amount of light that reaches underwater grasses. In addition to greater overall SAV growth, the upper estuary also has seen the diversity of underwater grasses increase in recent years. *Hydrilla verticillata*, an invasive exotic species that was the first type of SAV to recolonize shallow water habitat in the estuary, now comprises less than 10 percent of total SAV abundance in most years, compared to 80 percent in the 1990s. In addition to *Hydrilla*, the estuary now has populations of 12 different species of SAV.

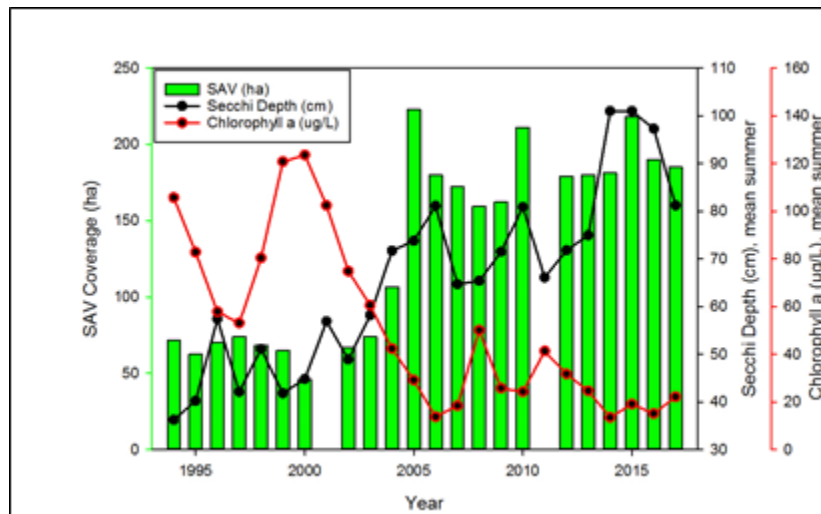
Figure 23. Various Water Quality Parameters in Gunston Cove

Although the general pattern of nutrient reductions leading to water quality improvements seems clear and has been observed in other parts of the Bay, water quality scientists are not certain of all the details and there are individual differences at play as well. Jones believes that the chlorophyll-A, water clarity and SAV acreage changes in Gunston Cove were triggered by the phosphorus reductions at Noman Cole, even though several decades elapsed between these two sets of events. He attributes this response lag to the persistence of phosphorus in bottom sediments in the cove; it is only when this phosphorus reservoir was depleted that the algal populations declined and the SAV rebounded.
