Breewood Tributary Restoration Tour

Chesapeake Bay Policy Committee

May 19, 2017

Breewood Tributary Restoration

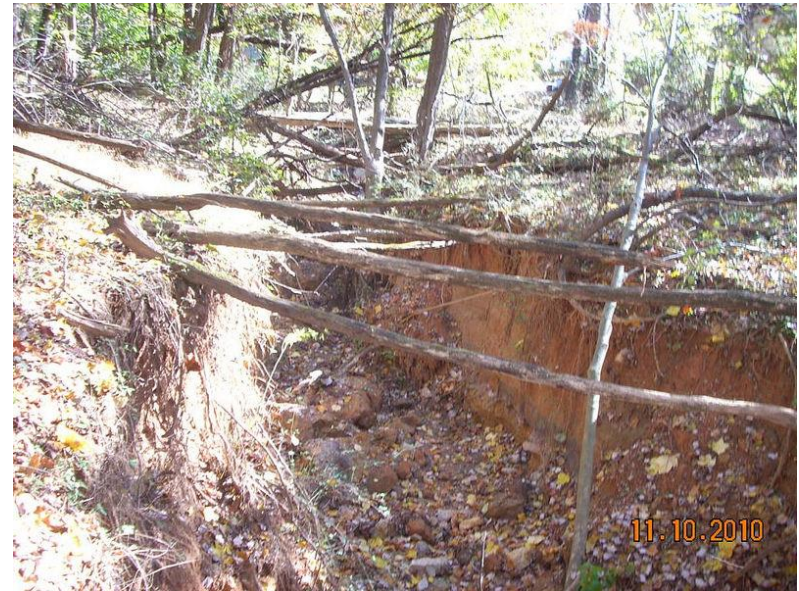
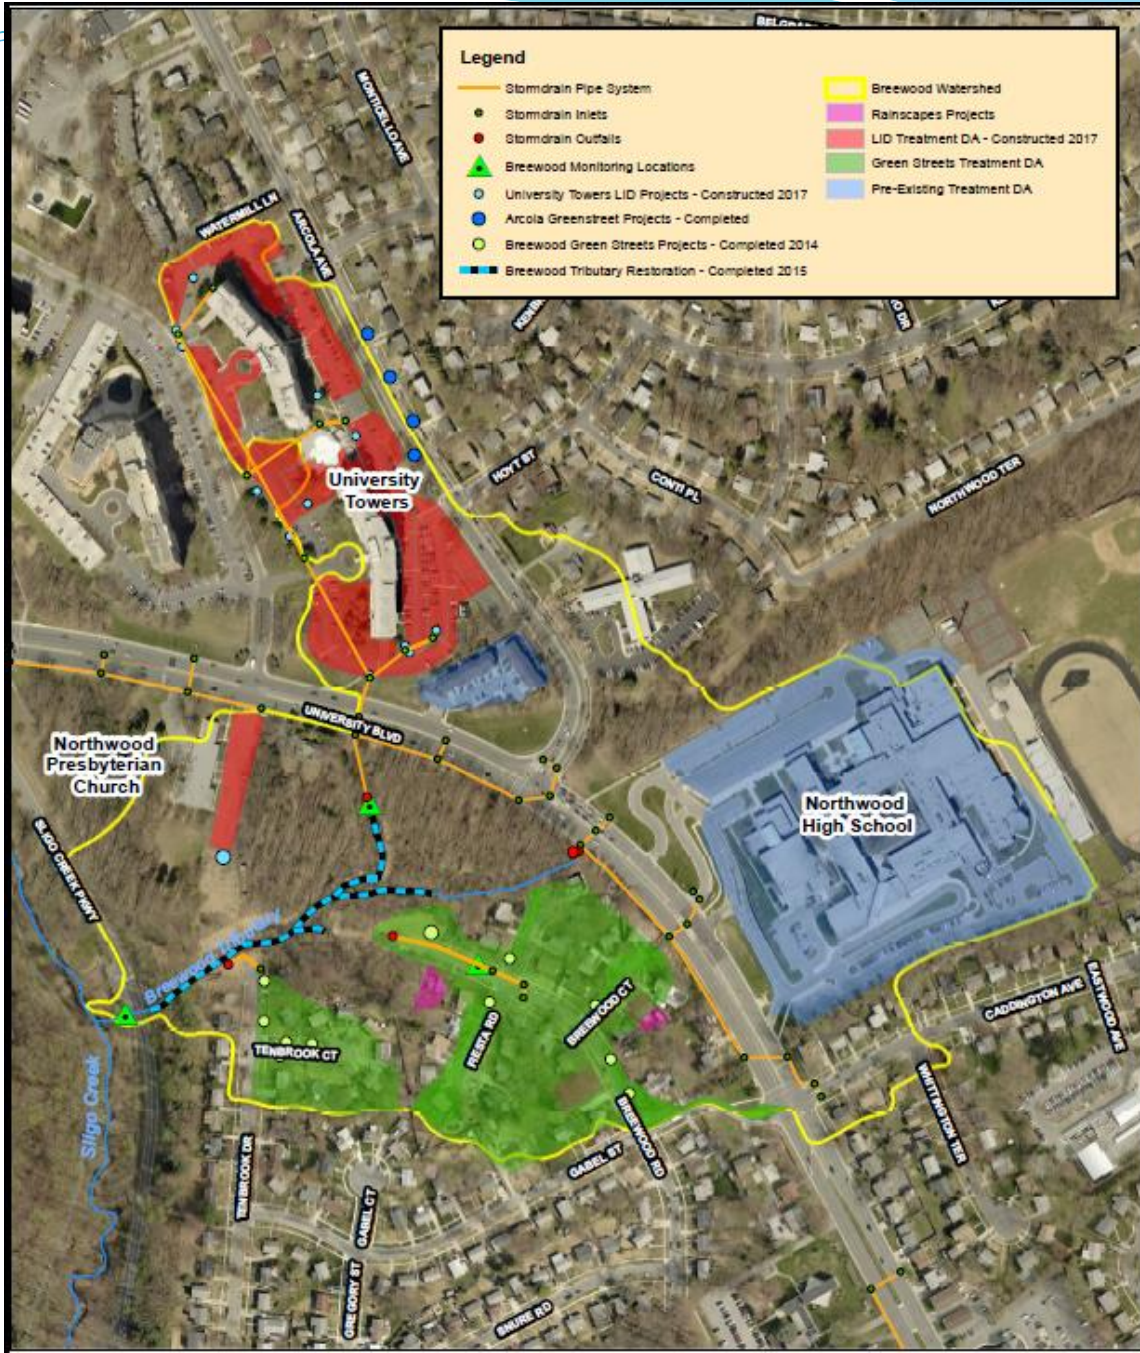
- 1200 foot first order stream
- 63 acre drainage area
- 42% impervious
- Medium density residential
- 2009 MDE appoved Breewood Tributary for comprehensive watershed restoration effort

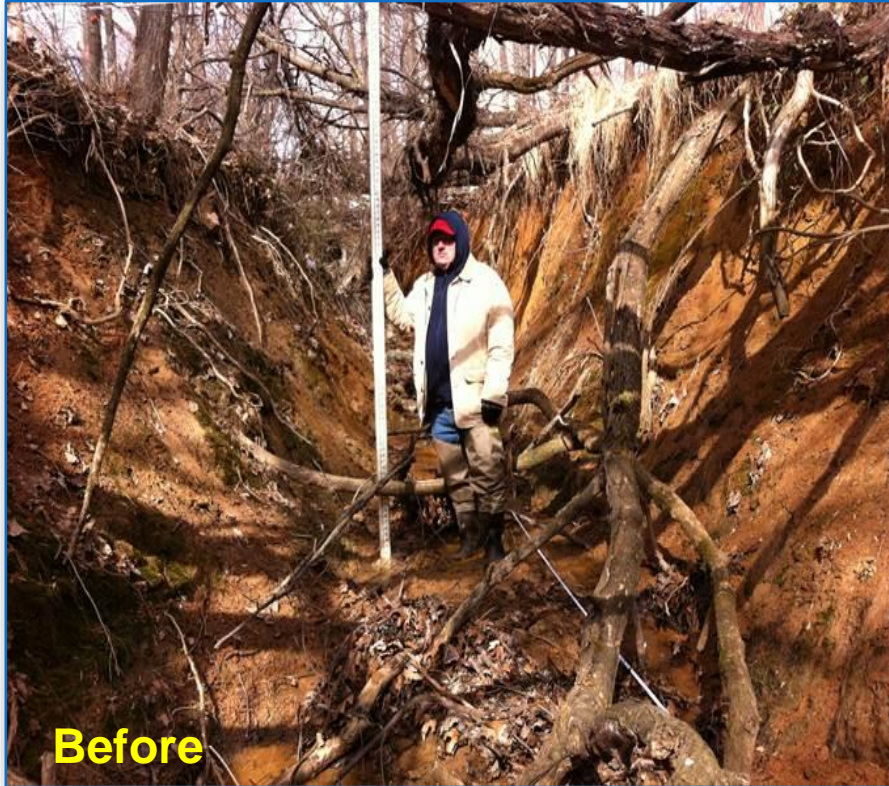
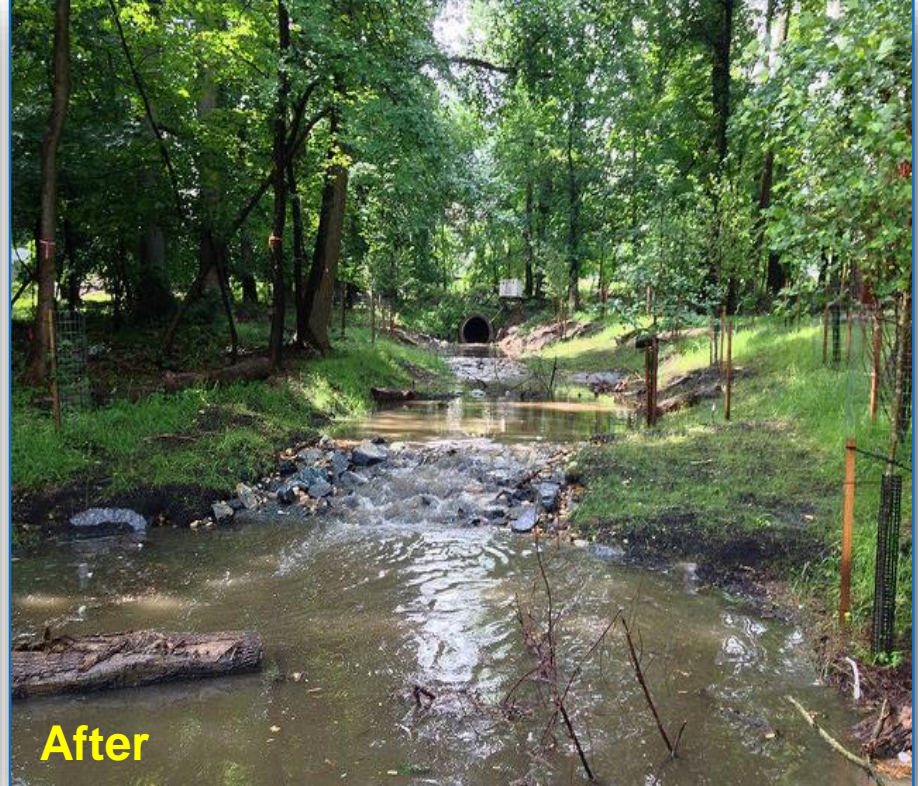
Breewood Stream Restoration Project

Length = 1,280 Feet
Completed - 2015

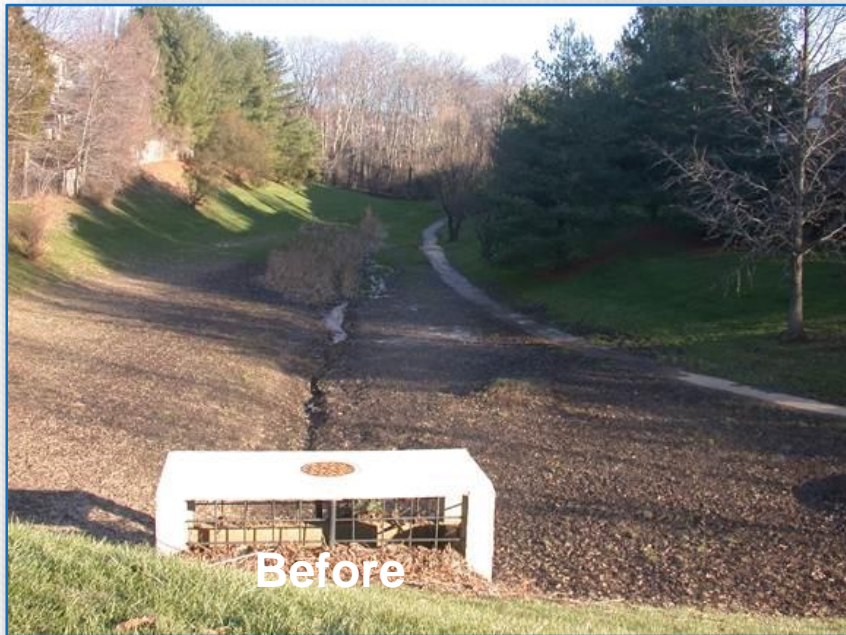
Fallsberry Stormwater Management Pond in Potomac, Maryland

Stormwater Management Pond Retrofits

Treated = 13 impervious acres
Completed – October 2014

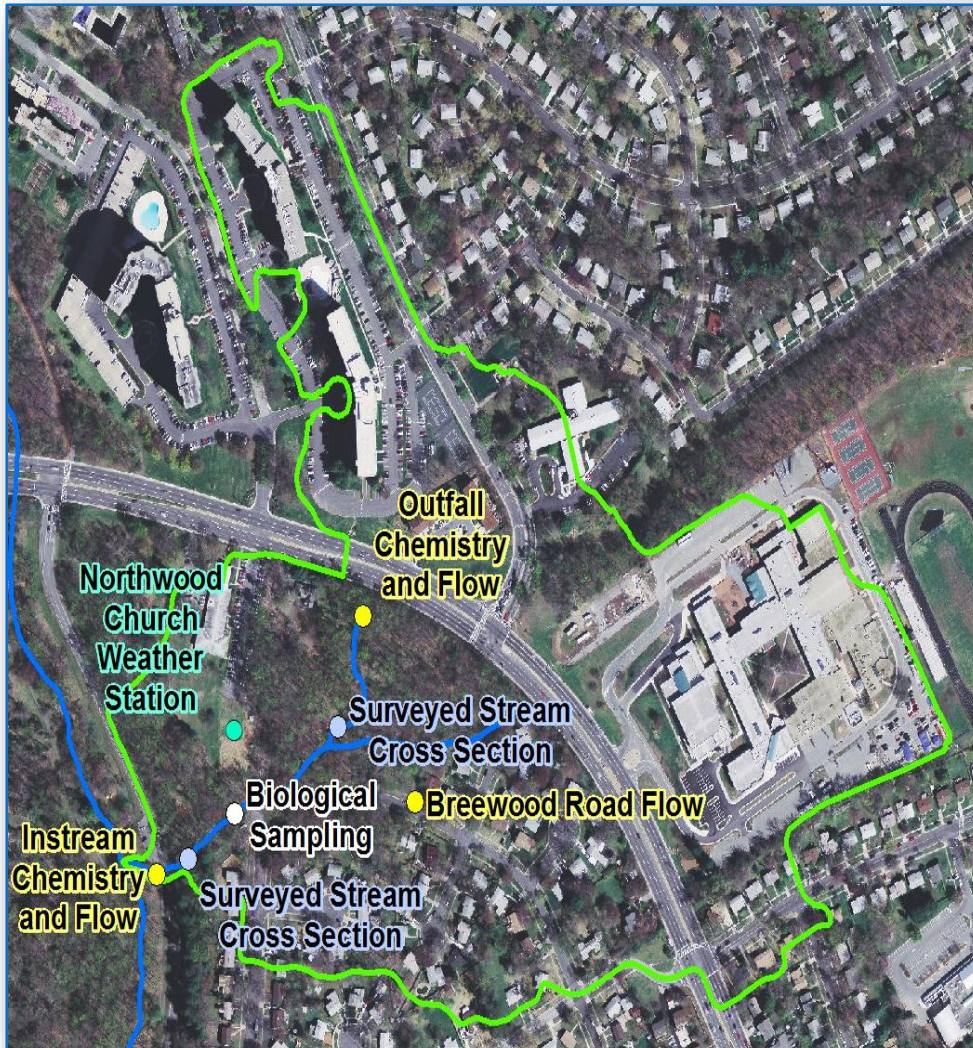
Breewood Tributary Monitoring- Monitoring Plan

- ▶ One outfall and instream monitoring station- water chemistry and flow
- ▶ Two stream geomorphology stations
- ▶ One biological monitoring station
- ▶ Weather station (rainfall)
- ▶ Continuous physical water chemistry monitoring (new)
- ▶ Two additional stations to monitor pre and post retrofit (RainScapes Neighborhoods) water quality and flow.
