POTOMAC RIVER WATER QUALITY IN THE WASHINGTON REGION - DRAFT

January 2019

POTOMAC RIVER WATER QUALITY IN THE WASHINGTON REGION

Prepared by the Water Resources Technical Committee

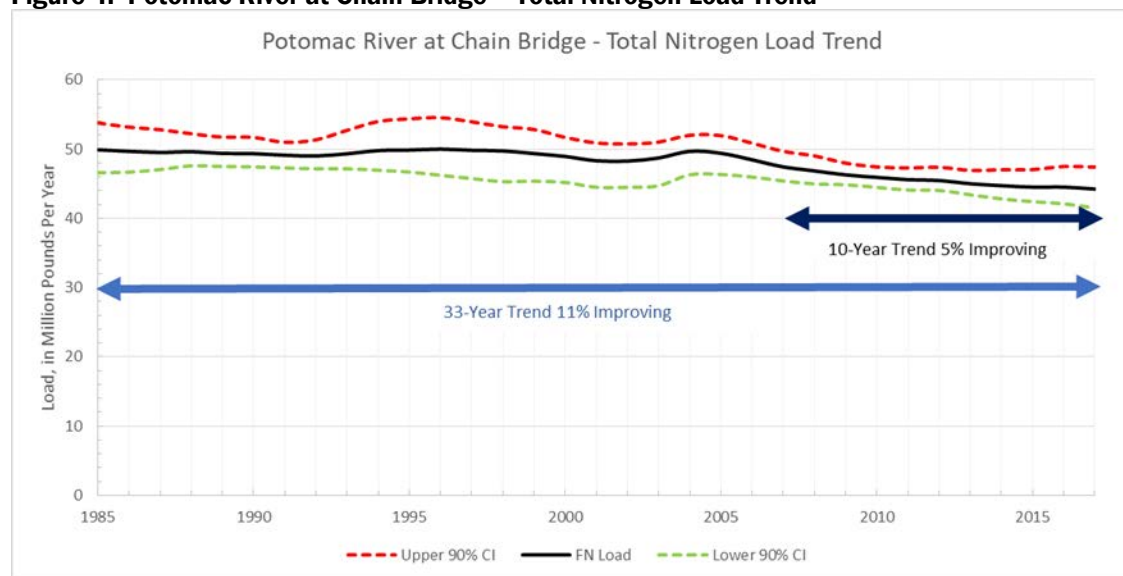
Figure 4: Potomac River at Chain Bridge – Total Nitrogen Load Trend

These charts show the trends in flow-normalized loads of the major Bay pollutants measured at the Potomac fall line at Chain Bridge by USGS. Total nitrogen and total phosphorus are shown in millions of pounds/year; total sediment; in billions of pounds/year.

The USGS data shows that loads of the three major pollutants at the Potomac fall line are lower now than in 1985, most likely due to nutrient reduction efforts in this portion of the watershed. However, the patterns differ between nitrogen (TN) on the one hand and both phosphorus (TP) and sediment (TS) on the other. Observed loads of TN have been flat to steadily declining over the 33-year span of the USGS monitoring data. Observed TP and TS loads over the same period have gone up and down and in both cases show increases (i.e. degrading trends) in the most recent 10 years. There is not a definitive explanation for the drivers of these observed changes in loads. Reductions in nutrients from wastewater plants and from agriculture probably account for most of the progress. In the case of the recent increases in flow-normalized TP and TS loads, it is thought that increases in animal agriculture and the resulting manure in certain portions of the watershed and increases in the amount of developed land above the Chain Bridge fall line have contributed to these degrading trends.

USGS uses statistical techniques to remove most of the variability in actual loads introduced by fluctuating hydrology. The resulting flow-normalized loads provide an illustration of how nutrient and sediment loads have altered because of man-made changes.

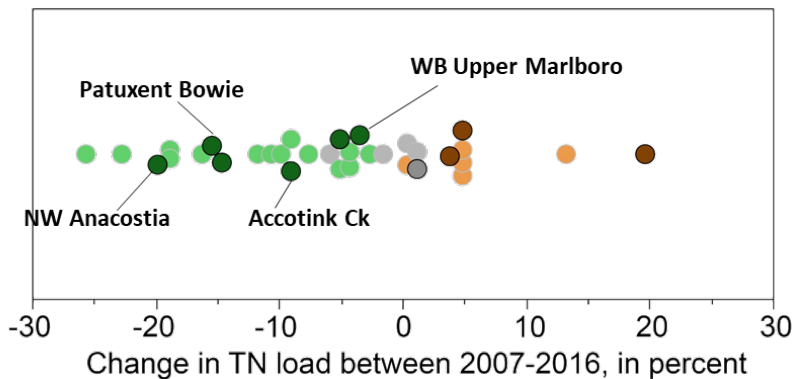
Figure 7: USGS Nontidal Monitoring Station – Change in Total Load 2007-2016

Nevertheless, some signs have emerged of progress in reducing nutrient loads from urban stormwater in portions of the COG region. The following charts show TN and TP load data from all of the USGS nontidal monitoring stations in the Potomac and Patuxent watersheds in the 10 years from 2007 - 2016. (See Figure 9 for a map of where these stations are located.) Improving load trends (shown as green circles) indicate pollution reduction progress; brown circles indicate degrading load trends. The stations at Northwest Anacostia, Patuxent Bowie, Accotink Creek, and Western Branch Upper Marlboro (all of which drain primarily urban areas, although not all of the watersheds are in the Potomac basin) all show improving trends for TN and Patuxent Bowie and Northwest Anacostia also show improving trends for TP. However, these trends are not definitive and there are other COG stations that drain urban watersheds that still show degrading trends.

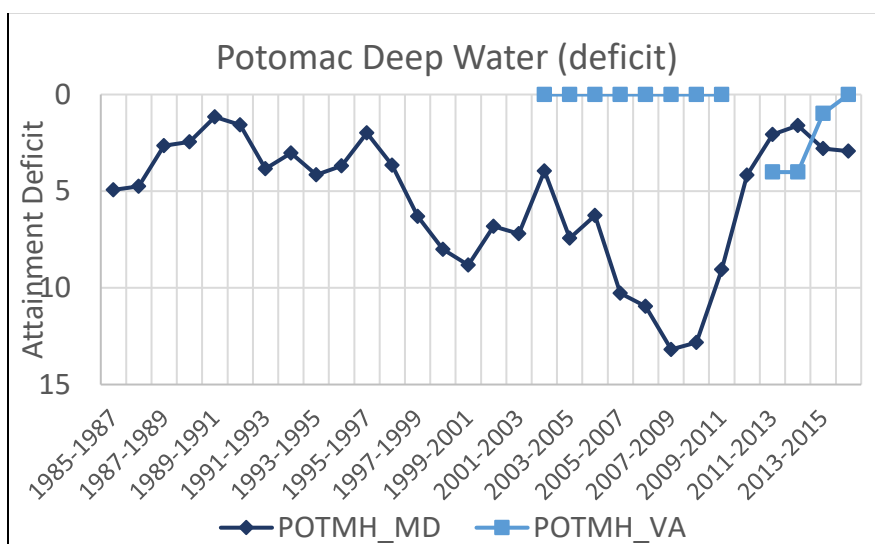
Figure 10: Attainment Deficit for the Potomac Deep Channel Stations in MD and VA

The two charts show attainment deficit for the deep channel and the adjacent deeper waters in the lower portion, or mesohaline section, of the Potomac estuary. POTMH-MD represents the Maryland portion of these waters, which comprise the bulk of the mainstem; POTMH-VA comprises Virginia’s portion, which includes a number of embayments on its side of the river. There is much less data for these Virginia waters and its water quality does not necessarily correspond to conditions in the main part of the estuary.

Although the charts show deficits in the range of 5 – 15 percent on a time- and volume-weighted basis for these segments (which means they actually are in attainment most of the time), it does appear that

water quality degradation bottomed out in the 2007-2009 period and has been improving since then, which analysts attribute largely to reductions in wastewater nutrients. And there is other data that provides evidence of recent improvement in water quality in the Potomac estuary.

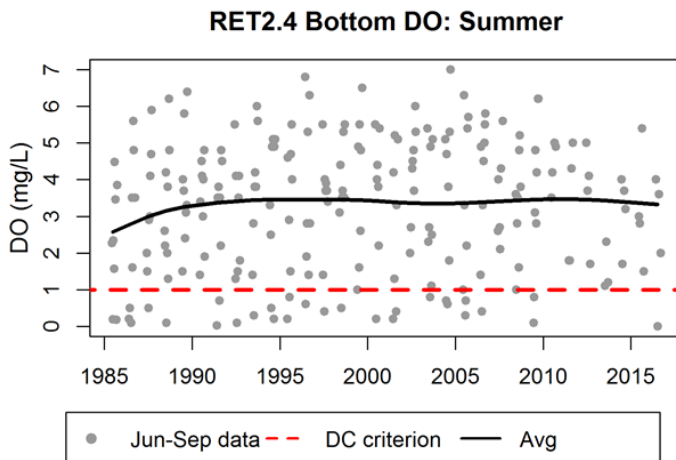
Figure 15: Bottom Dissolved Oxygen: Summer for station RET2.4

Even where overall statistical analysis shows no signs of improvement, analysts believe they can pick out smaller signs that progress is being made. At the RET 2.4 station near the Route 301 Bridge, for example, the monitoring data from recent years has only 1 value below the deep channel instantaneous criterion of 1 milligram/liter.

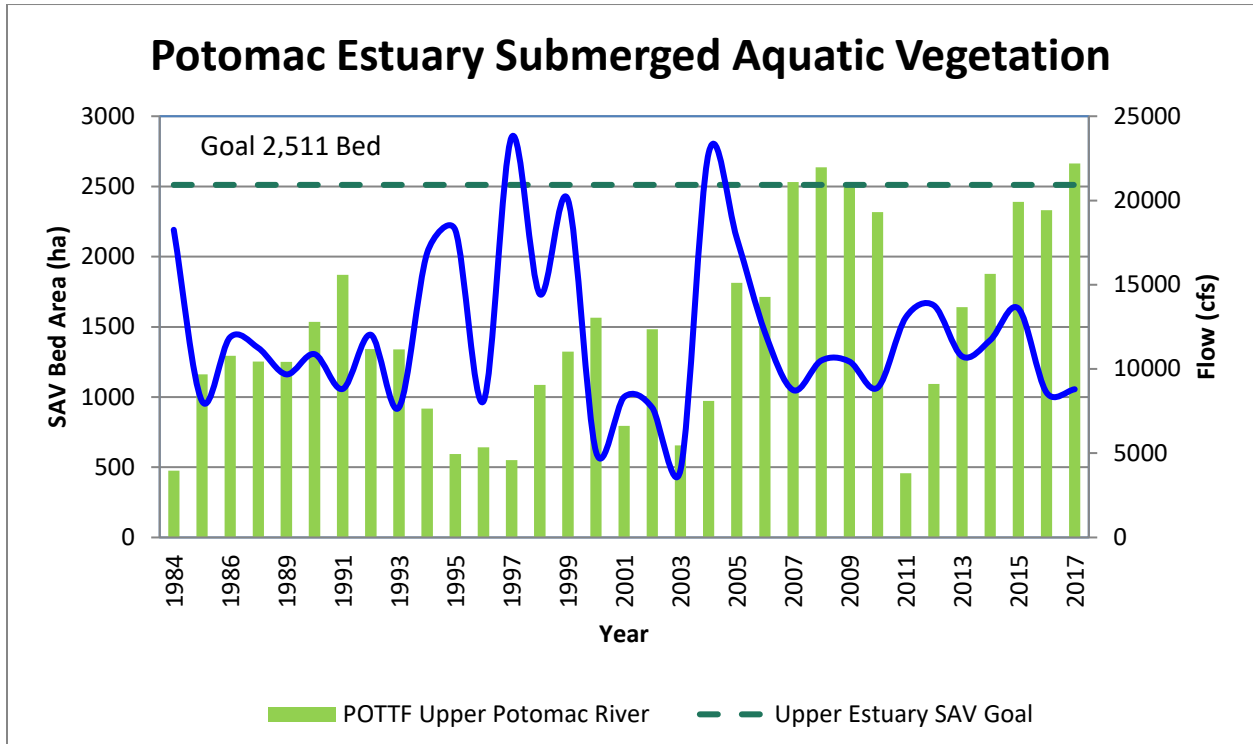
Figure 18: Potomac Estuary SAV (Upper Portion) and Flow at Chain Bridge

The amount of SAV growing in the upper estuary fluctuates annually because of changes in weather conditions and other factors, but overall it has increased significantly in recent years as nutrient levels in the water have decreased. Fewer nutrients tends to lead to less algal growth, which in turn increases the amount of light that reaches underwater grasses. In addition to greater overall SAV growth, the upper estuary also has seen the diversity of underwater grasses increase in recent years. *Hydrilla verticillata*, an invasive exotic species that was the first type of SAV to recolonize shallow water habitat in the estuary, now comprises less than 10 percent of total SAV abundance in most years, compared to 80 percent in the 1990s. In addition to *Hydrilla*, the estuary now has populations of 12 different species of SAV.

The SAV success story is still somewhat limited, however. The Chesapeake Bay Program has established initial targets for the extent of SAV acreage in different parts of the Bay and the tidal waters of its tributaries, including the Potomac. SAV growth in the tidal freshwater portion of the Potomac estuary consistently met this target in recent years, except for 2011 and 2012. The underwater grass populations in the river remain sensitive to environmental disturbance and in 2011 and 2012, weather conditions that favored greater algal growth resulted in fewer acres of underwater grasses in the upper estuary. Moreover, SAV growth tends to drop off in the lower, saltier portions of the estuary, where the amount of SAV acreage has not yet met any of the initial Bay Program targets. While some areas like the Upper Potomac Estuary have met initial restoration targets, the entire Chesapeake Bay remains far short of the ultimate goal: underwater grasses growing in all of the shallow water habitat of the Bay and the tidal waters of its tributaries.

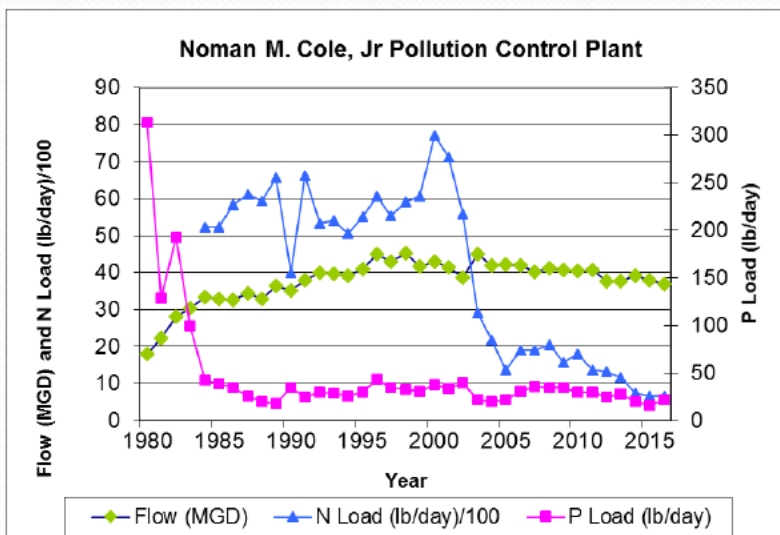
Figure 20. Flow and Loads at Noman Cole Plant

Gunston Cove’s road to recovery began with a ban on phosphates in detergents in the 1980s and the implementation of phosphorus controls at all of the major wastewater plants discharging to the estuary in the late 1970s and early 1980s, including the Noman Cole plant in Fairfax County. These were followed by controls on nitrogen discharges in successive periods from 2000-2005 and again since 2015. (See Figure 20.)

Between 1980 and 1985, the amount of phosphorus discharged into the lower Pohick Creek by the Noman Cole plant decreased by about 85 percent and the amount of phosphorus leaving the plant has remained at the same low level despite increases in the flow of wastewater to the plant. The discharge of nitrogen continued to increase until 2000-2005, when Noman Cole implemented its first round of biological nitrogen removal, achieving reductions of about 85 percent. Noman Cole implemented its second round of nitrogen reductions in 2013.

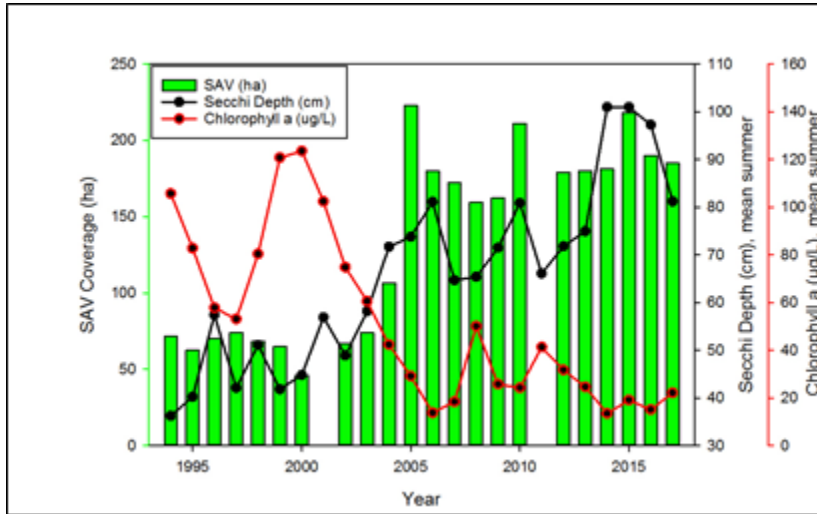
Figure 23. Various Water Quality Parameters in Gunston Cove

The water quality response can be seen in figures 21, 22 and 23 - a small amount of SAV growth was seen in the wake of the initial reductions in wastewater phosphorus. However, summertime levels of chlorophyll-A, a measure of the amount of algal growth, remained elevated and, correspondingly, water clarity, as measured by Secchi disk depth, remained relatively poor through 2000. Then, at various points between 2001 and 2005, chlorophyll-A levels declined dramatically – indicating a major reduction in algal populations – and water clarity improved. These are believed to be major factors in the significant expansion of SAV acreage subsequently seen in Gunston Cove.

Although the general pattern of nutrient reductions leading to water quality improvements seems clear and has been observed in other parts of the Bay, water quality scientists are not certain of all the details and there are individual differences at play as well. Jones believes that the chlorophyll-A, water clarity and SAV acreage changes in Gunston Cove were triggered by the phosphorus reductions at Noman Cole, even though several decades elapsed between these two sets of events. He attributes this response lag to the persistence of phosphorus in bottom sediments in the cove; it is only when this phosphorus reservoir was depleted that the algal populations declined and the SAV rebounded.
