# WASHINGTON AND OLD DOMINION TRAIL SIX INTERSECTION STUDY

## *RECOMMENDATIONS REPORT*

*MAY 2012*

TOOLE DESIGN GROUP

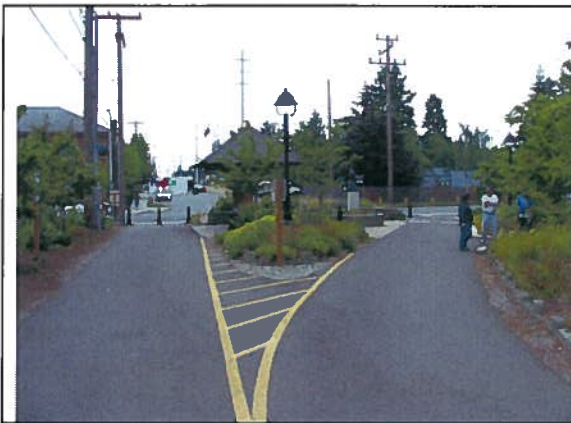
The existing 10 foot trail and crossing requires users to cross essentially in single file. Widening the trail approach and crosswalk to 14-20 feet will allow larger platoons of users to cross in less time without conflicting with crossing users. The width of the widening and curb ramp will be contingent upon the approach geometry of each intersection. It is recommended that the curb ramps be designed to match the full width of the trail with flares located outside of the trail width where it is determined they are necessary. During reconstruction projects, the trail approach could be split into two segments to promote the separation of crossing trail traffic (minimizing conflicts between opposing directions of traffic) and to prevent motorists from thinking it is a roadway into which they can turn.

*Figure 2 - Example split trail crossing, Interurban Trail, Seattle*

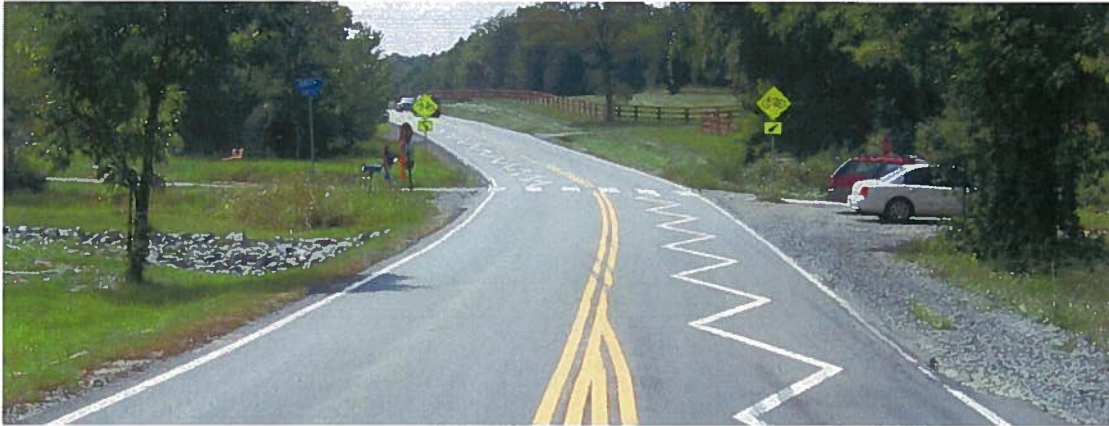
This parking presents a safety hazard to trail users and motorists by limiting sight lines, introducing unexpected parking maneuvers within the roadway, and creating unexpected street crossings. Consideration should be given to expanding the parking area on the northeast side (old Judith Road)

*Figure 5: The existing parking and portions of the vegetation are limiting sight lines between trail users and motorists below the clearance areas recommended by AASHTO*

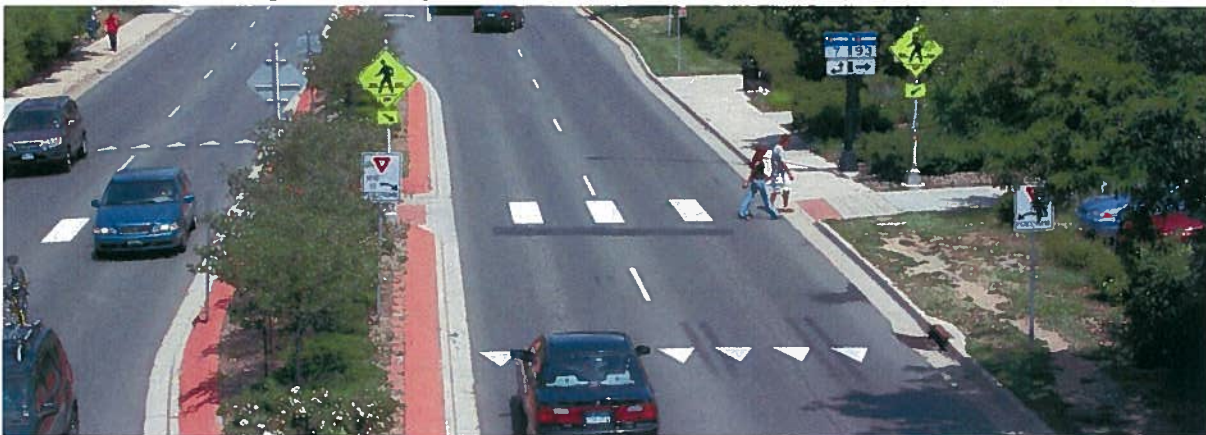
It is recommended a yield line be located 20 feet in advance of the crossing to improve the comfort of the trail users crossing the roadway.

*Figure 6: Example of an advanced yield line utilized in conjunction with a Rapid Flashing Beacon installation in Boulder, CO*

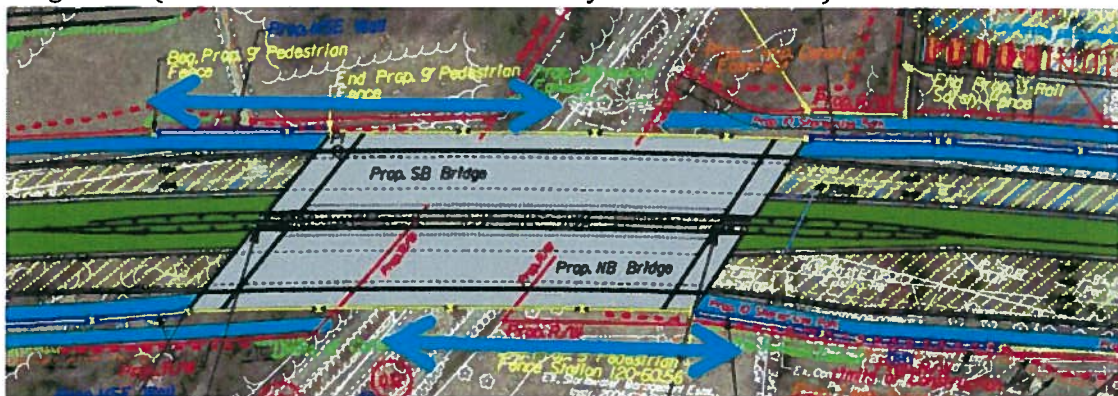
It is understood that VDOT has preliminary design completed for a widening of Belmont Ridge Road which would include a bridge over the W&OD Trail. Due to the high vehicle speeds and low yielding rates, this grade separation project should be a high priority for installation to ensure the safety of trail users from potentially fatal crashes and motorists from potentially severe rear end crashes. The preliminary design plans depict the provision of 10 foot shared use paths on both sides of Belmont Ridge Road with two connections to the trail provided. It is recommended the proposed plan be modified to provide four connections to the trail to limit the need for trail users to cross Belmont Ridge Road (two new connections shown with cyan colored arrows).

Figure 7: VDOT preliminary engineering plan with TDG recommendation for completing sidewalk network on both sides of the roadway

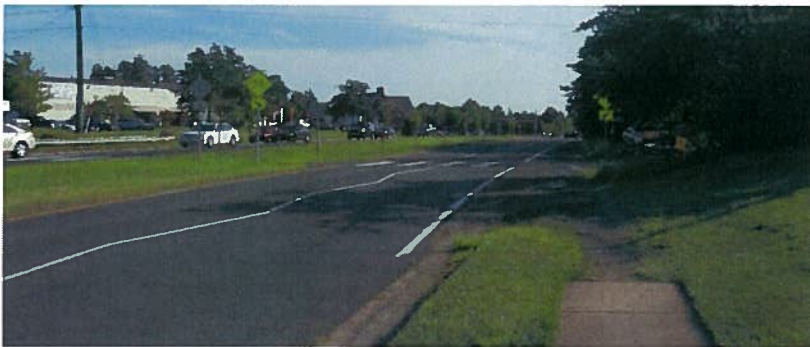
Sidewalks end unexpectedly on the approach to the trail from the adjacent sidewalk network. It is recommended the sidewalk system be completed on both sides of Sterling Boulevard between the trail and the adjacent intersections.

*Figure 9: It is recommended to trim existing vegetation and complete the sidewalk connection to the trail in addition to providing advanced yield line and rapid flashing beacons*

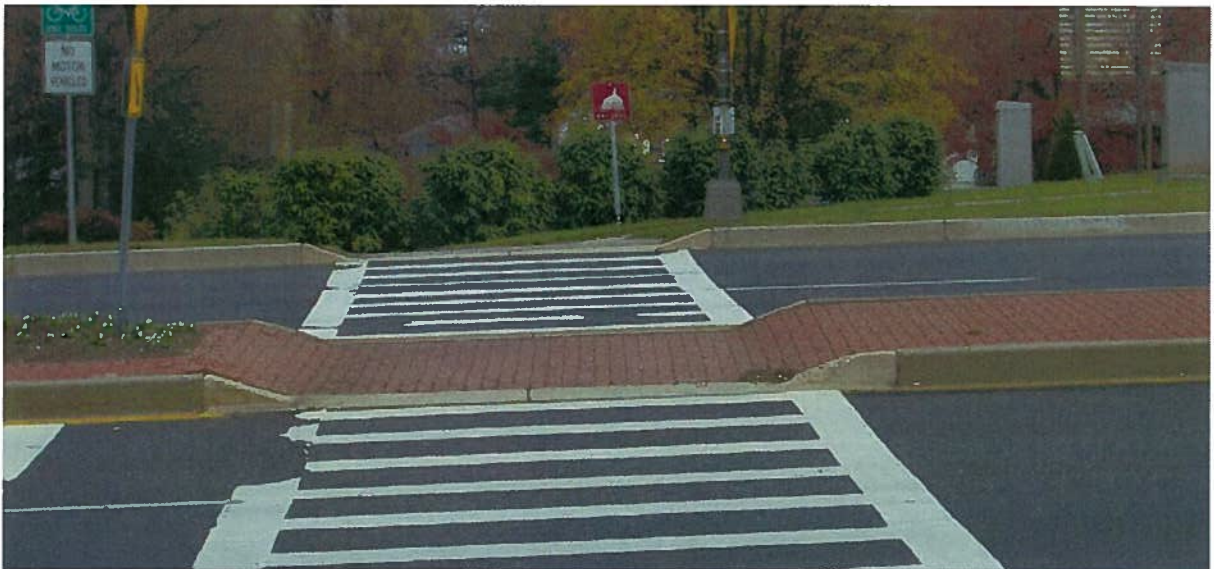
A wider crossing will allow more trail users to stage within the median. Given the narrowness of the existing a median, the wider opening will allow users to angle themselves within the median so trailers and longer bikes will not be exposed to cross traffic should they be waiting in the median. The median should also be designed to contrast with the roadway to help trail users visualize the "protected" area where they can wait without being exposed within an adjacent travel lane.

*Figure 11: Example of widened median with full width curb cut and differentiating surface treatment*

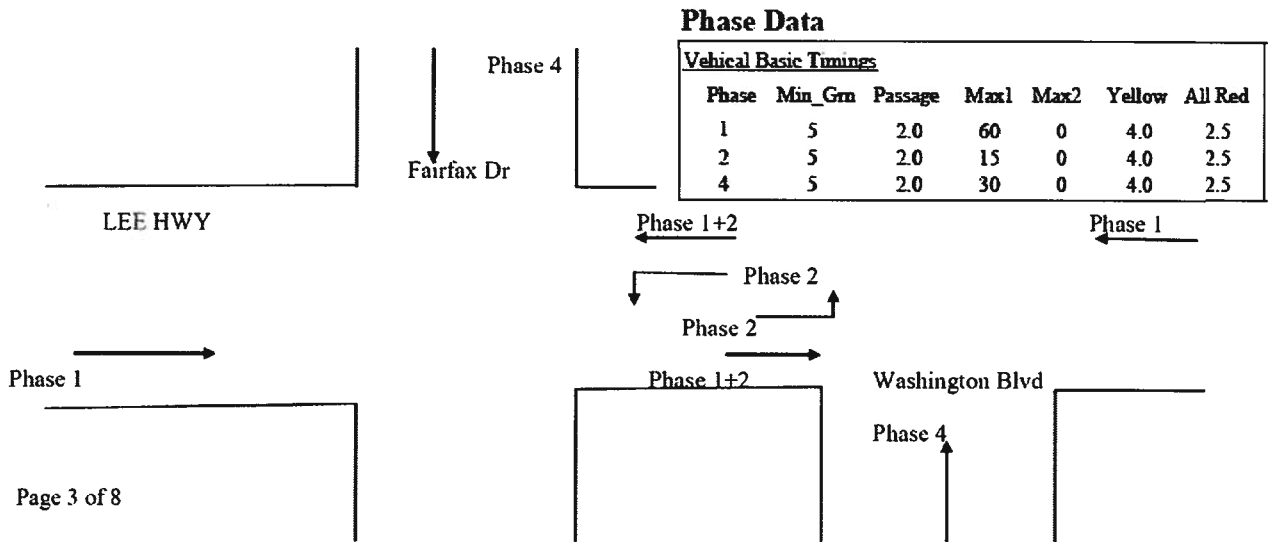
It is recommended a study be conducted to assess optimization of the traffic signal to reduce delay, minimize confusion, and improve safety. The existing phases with timing are shown below:

Figure 14: Signal Timing Diagram with Timing Information Provided by Arlington County

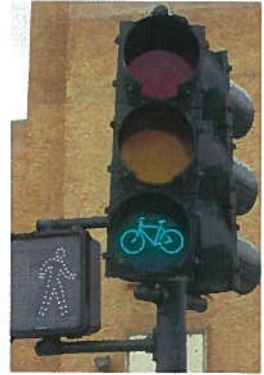
Install bicycle signals to signify additional “legal” time for bicyclists to enter the intersection (technically they can only enter during the solid walk portion of the phase). Recent research completed on the Mount Vernon Trail in Alexandria (approved by FHWA) along with other locations in the United States indicates a bicycle signal may improve compliance and safety at trail crossings.

Figure 15: Bike Signal, NYC

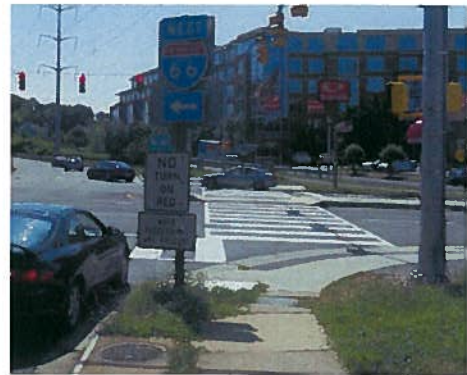
- Add advance warning sign for right turning traffic of W&OD trail – after driveway closest to Lee Highway for westbound approach
- Relocate eastbound NTOR signs to improve sightline to trail by locating signs near traffic light or on traffic island

Figure 16: Location of Existing Signs Block View of Trail

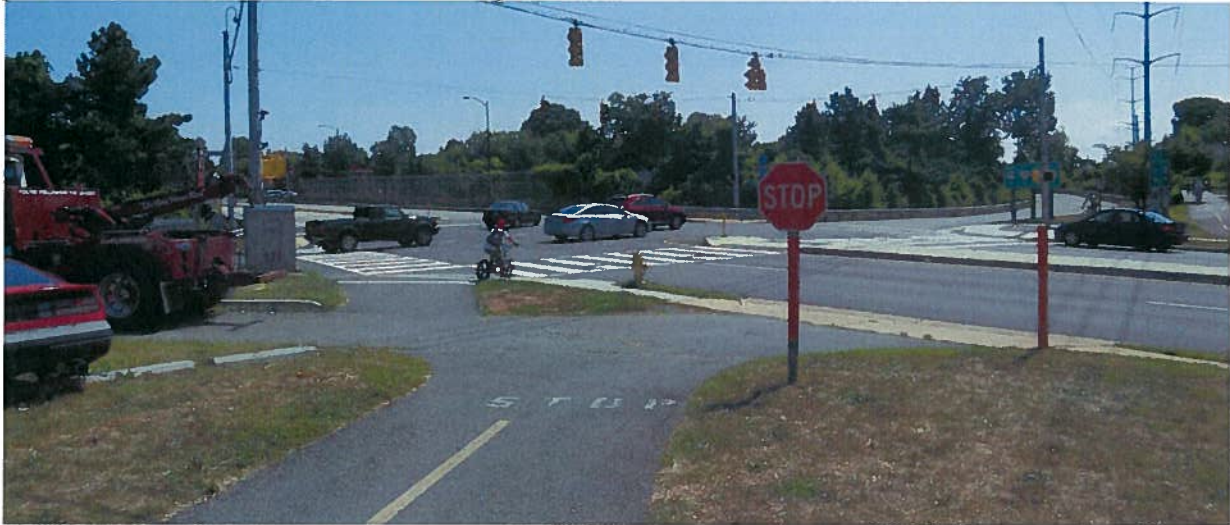
It is recommended the existing trail approaches be defined more clearly approaching Lee Highway. An interim measure would be to add pavement markings to define the edges of the trail and to add a centerline leading up to the crosswalk.

*Figure 17: The existing approaches to Lee Highway do not clearly define the primary trail alignment to the user. The driveway should be subservient to the trail at this location with some wayfinding signs provided to guide the user towards the crosswalk for the trail/Metro Station or alternatively to Lee Highway via the driveway.*
