Metropolitan Washington COG Stream Restoration Technical Session:

Stream Restoration Design and Program Considerations for Crediting and Tracking Benefits

Matt Meyers, Chief
Watershed Project Implementation Branch
Department of Public Works and Environmental
Services

Fairfax County, Virginia

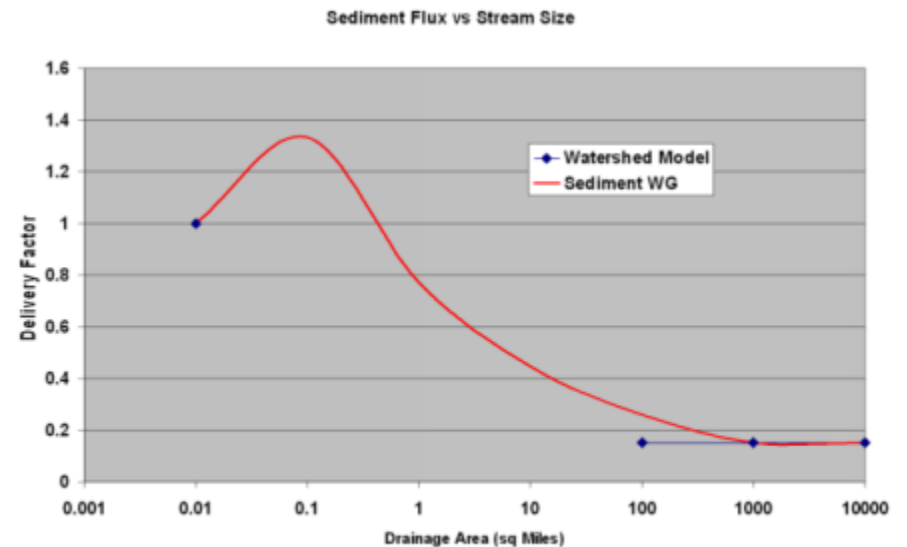
Figure 2. Edge of Stream Sediment Delivery Curve in CBWM

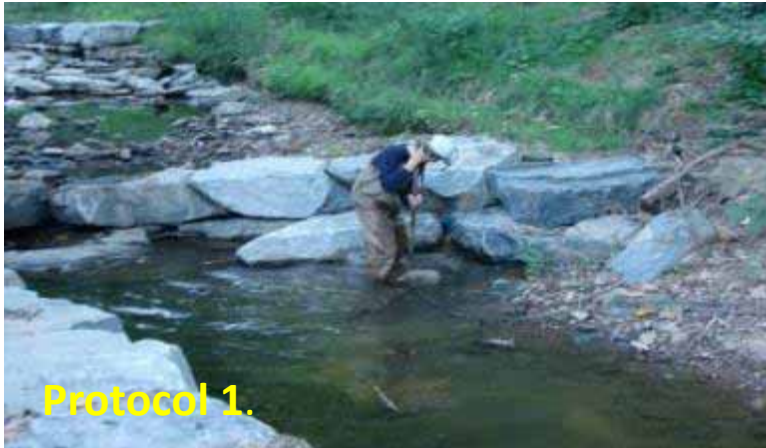
1. Prevented sediment approach

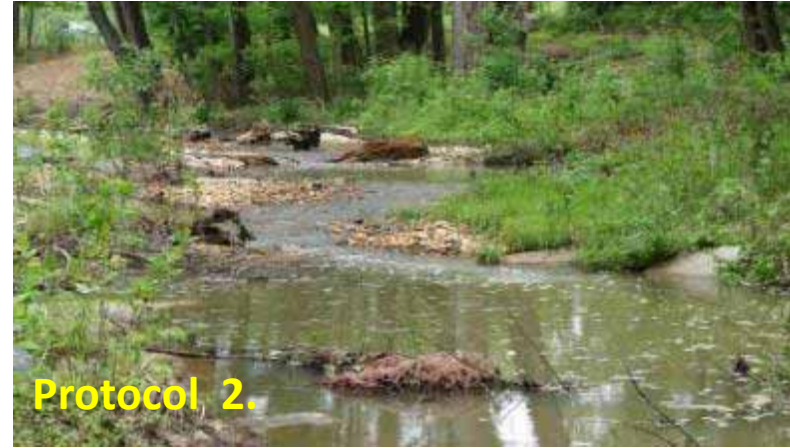
2. In-stream denitrification

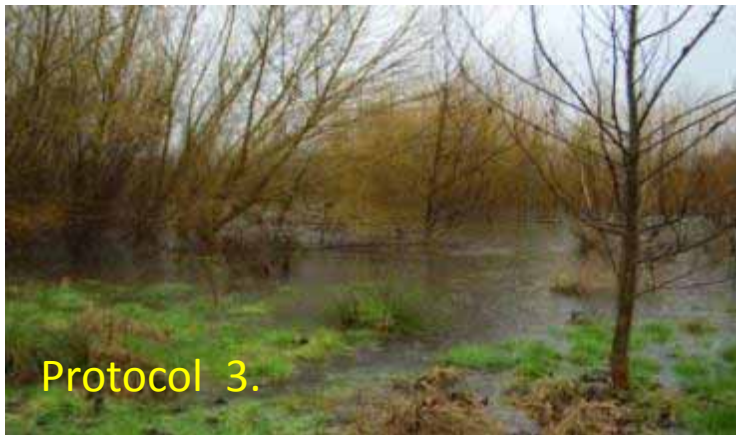
3. Flood plain reconnection

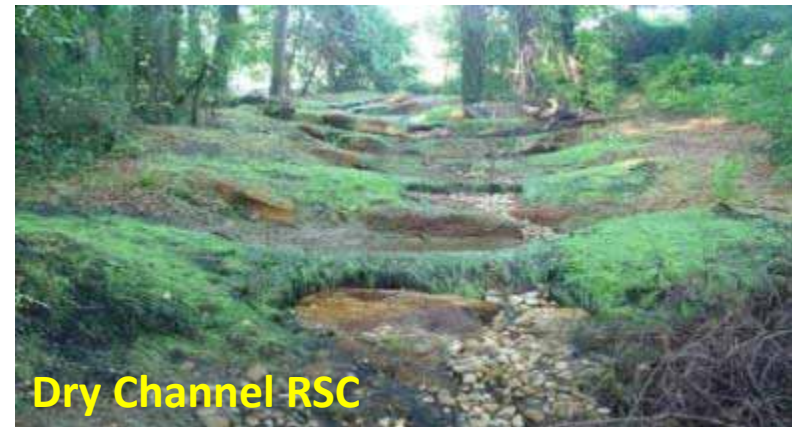
4. The "tweener" Dry Channel RSC

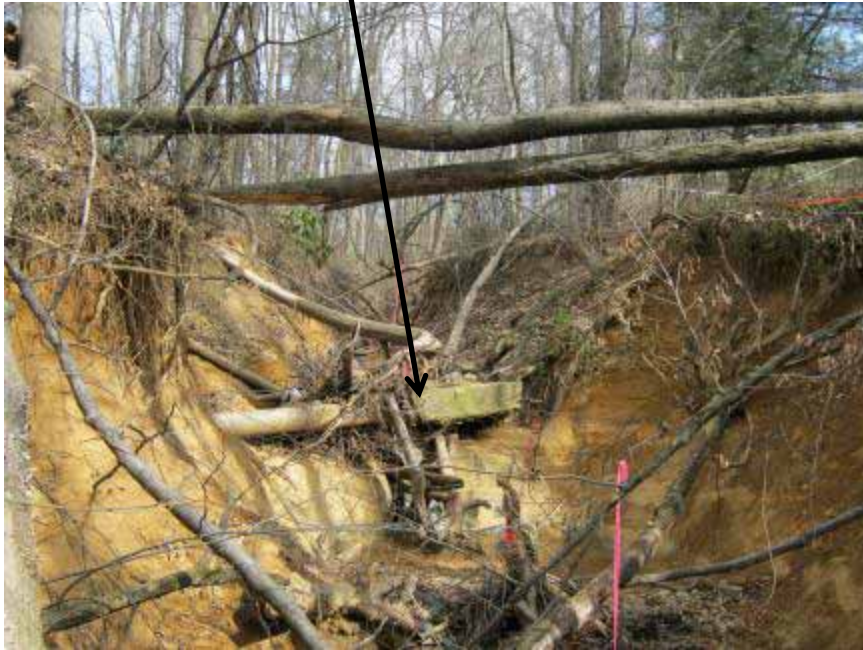
Before: Exposed sanitary sewer line and highly eroded channel.

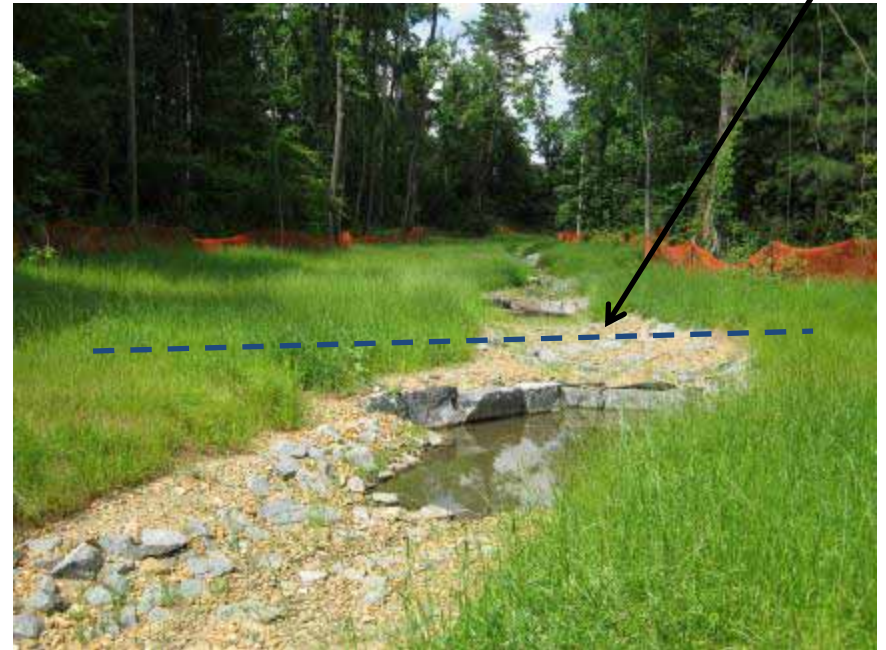
After: Before trees and shrubs were planted

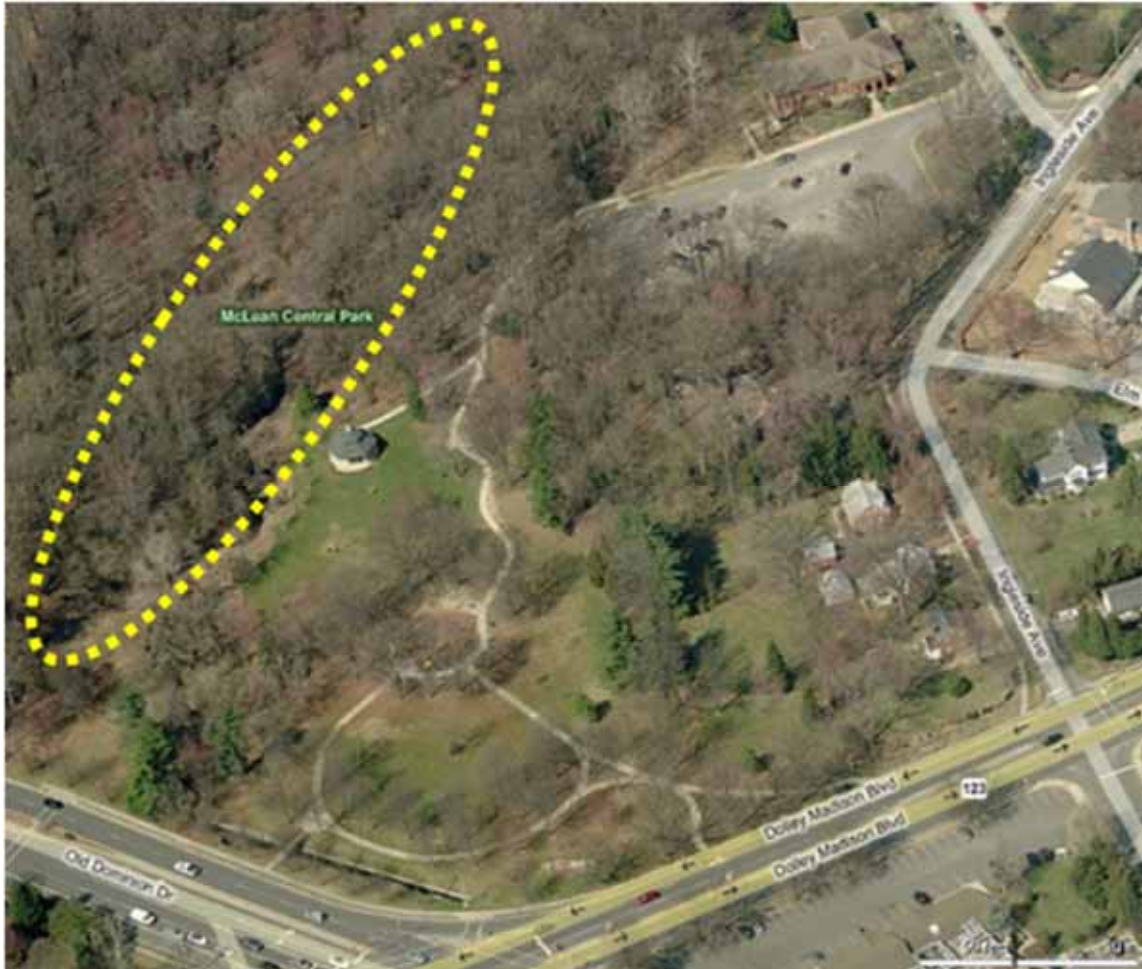
Approximately 1,400 liner feet of Dead Run stream that runs through McLean Central Park was stabilized with various practices including encapsulated soil lifts, toe protection, stone vanes, compost berms, and fiber log rolls. The stormwater outfall from Dolley Madison library was restored to include a sand filter step-pool system and wetland feature. The entire site was re-vegetated with extensive native plantings of trees, shrubs, grasses and wildflowers.

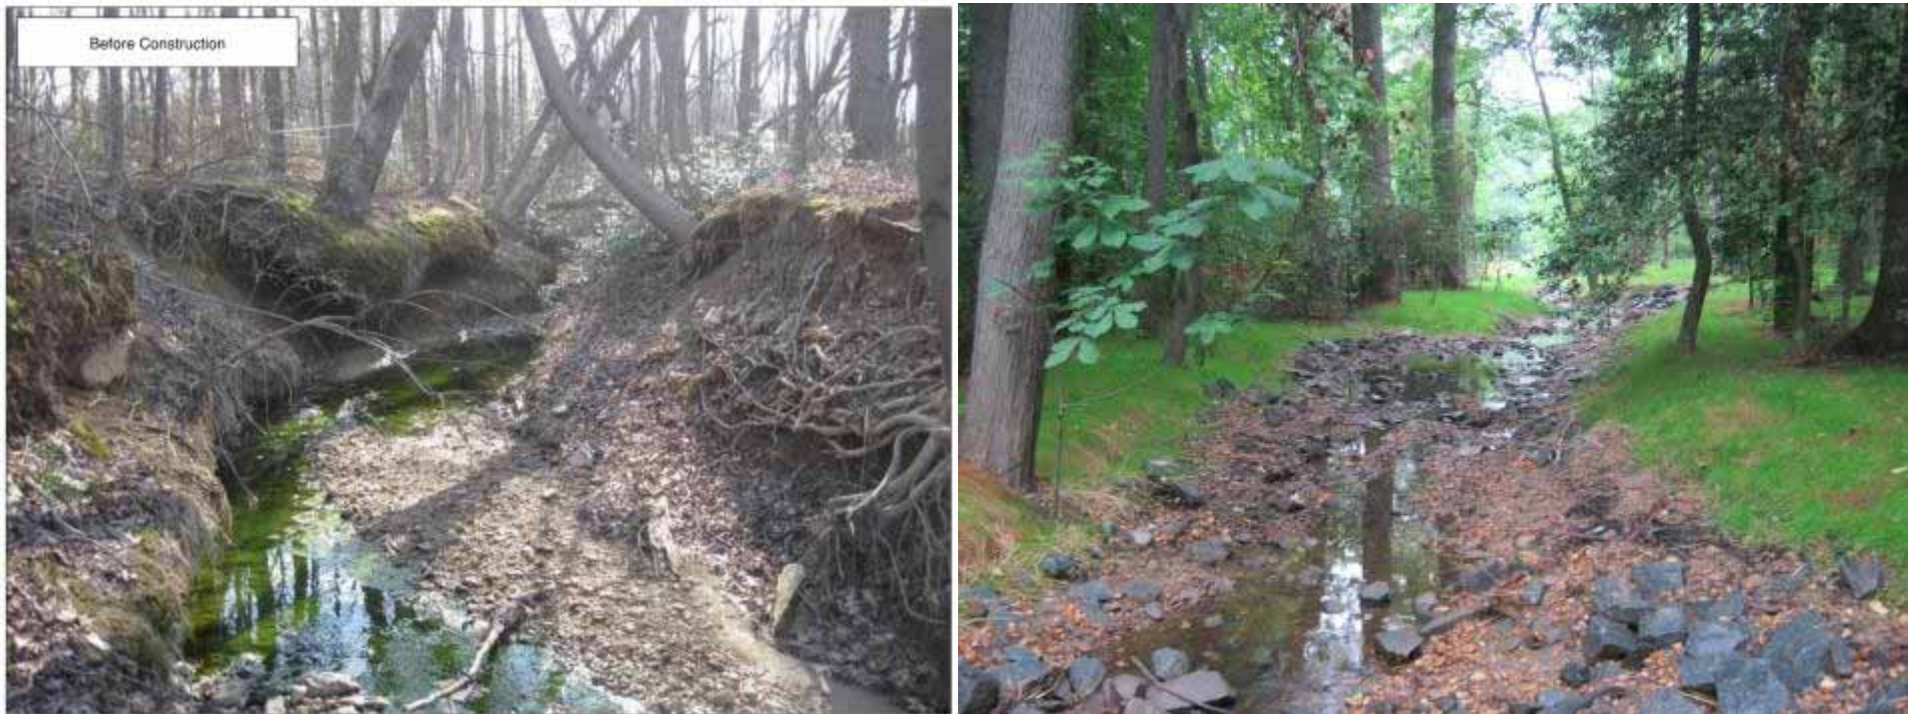
Government Center Stream Restoration - before and after
Restoration of 1,000 LF of an unnamed tributary of Difficult Run.

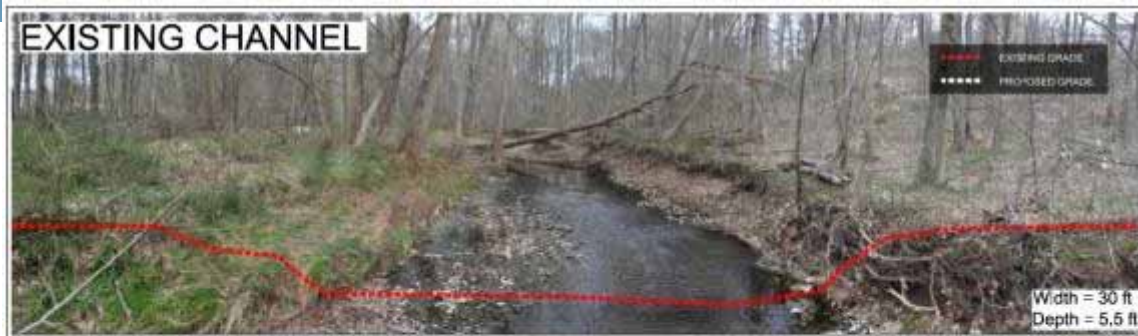
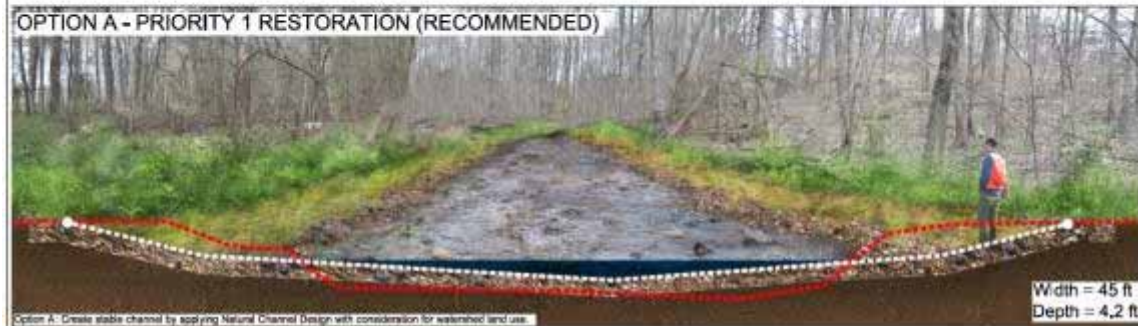
**XS2 - USGS GAGE LOCATION
(D.A. = 2,712 AC)**

Flatlick Branch Concept Design Cross-Sections.
Prepared by Wetland Studies and Solutions, Inc.
