POTOMAC RIVER WATER QUALITY IN THE WASHINGTON REGION - DRAFT

POTOMAC RIVER WATER QUALITY IN THE WASHINGTON REGION

Prepared by the Water Resources Technical Committee

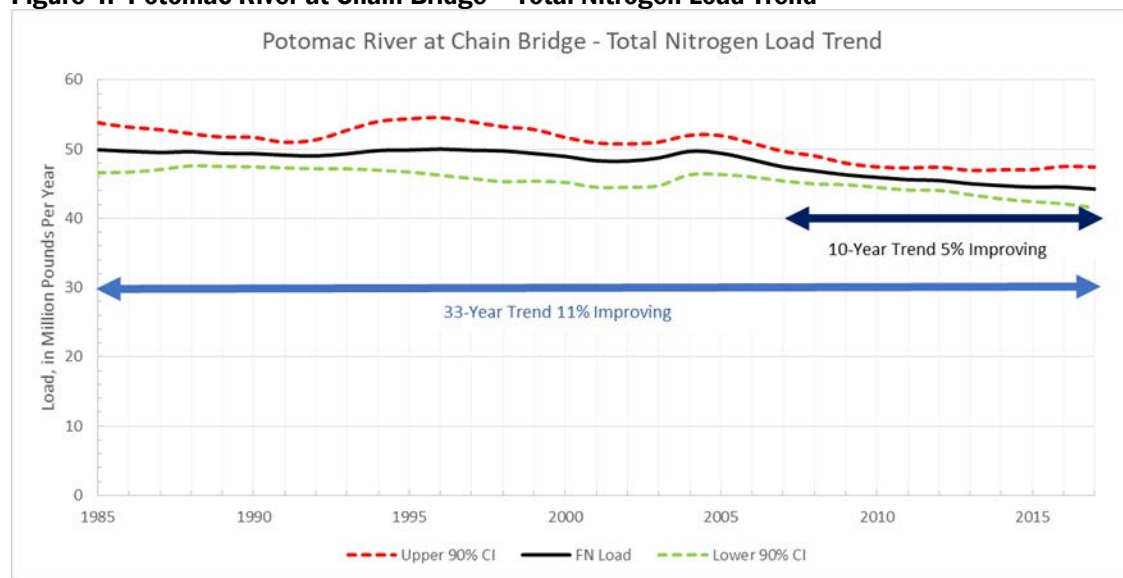
Figure 4: Potomac River at Chain Bridge – Total Nitrogen Load Trend

These charts show the trends in flow-normalized loads of the major Bay pollutants measured at the Potomac fall line at Chain Bridge by USGS. Total nitrogen and total phosphorus are shown in millions of pounds/year; total sediment; in billions of pounds/year.

The USGS data shows that loads of the three major pollutants at the Potomac fall line are lower now than in 1985, most likely due to nutrient reduction efforts in this portion of the watershed. However, the patterns differ between nitrogen (TN) on the one hand and both phosphorus (TP) and sediment (TS) on the other. Observed loads of TN have been flat to steadily declining over the 33-year span of the USGS monitoring data. Observed TP and TS loads over the same period have gone up and down and in both cases show increases (i.e. degrading trends) in the most recent 10 years. There is not a definitive explanation for the drivers of these observed changes in loads. Reductions in nutrients from wastewater plants and from agriculture probably account for most of the progress. In the case of the recent increases in flow-normalized TP and TS loads, it is thought that increases in animal agriculture and the resulting manure in certain portions of the watershed and increases in the amount of developed land above the Chain Bridge fall line have contributed to these degrading trends.
