ITS  
NUMBER 52

# Interpreting The Secretary of the Interior's Standards for Rehabilitation

## Subject: Incorporating Solar Panels in a Rehabilitation Project

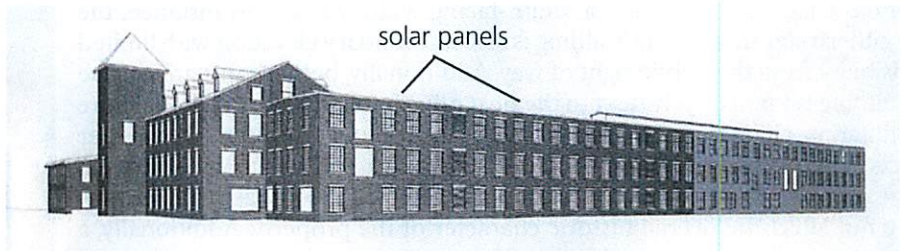
*Because of the size of this historic mill, a large array of solar panels could be installed on the flat roof without being seen from the ground.*

The rehabilitation of this mid-nineteenth century mill incorporated a large, roof-mounted photovoltaic installation. Although the historic building does not have a parapet wall at the roofline, the height of the building and the arrangement of the panels render the entire installation invisible from the ground. It is important to note that the panels are placed horizontally. Had the panels been installed with a vertical tilt, the angle required to maximize efficiency would have caused the panels to extend significantly higher above the roof. Simply changing the direction in which the panels are tilted can affect their visibility and reduce their impact on the character of the historic property.

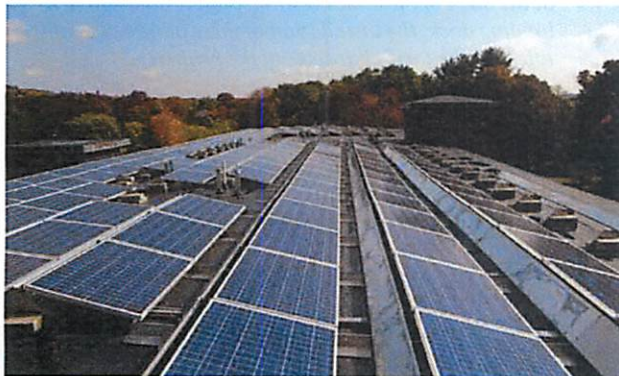
*Solar panels installed on the flat roof.*

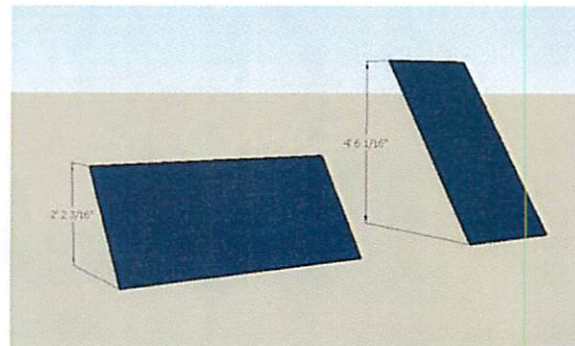
*By placing the panels horizontally, the overall height of the installation and its visibility is reduced.*

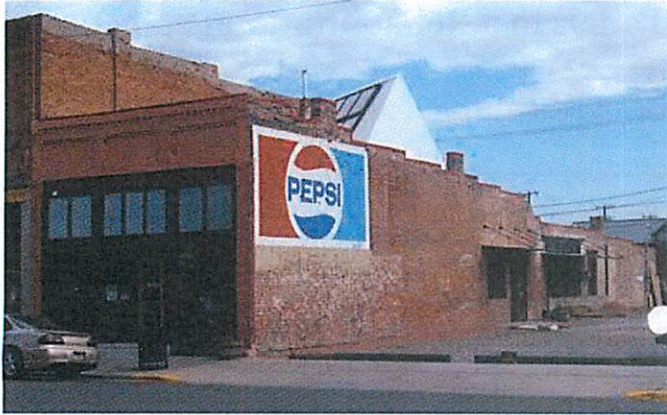
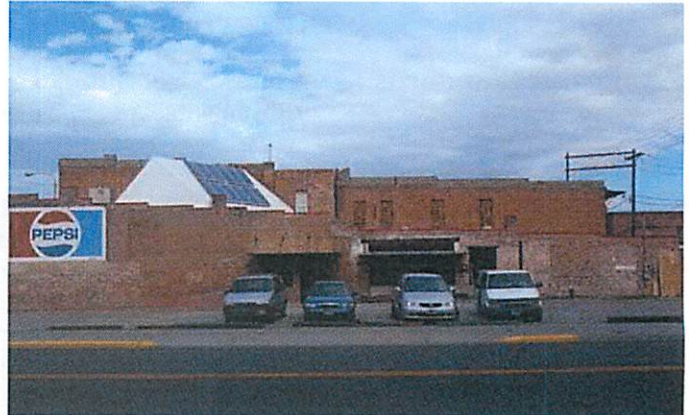
*The addition of a large rooftop monitor featuring skylights on the front slope and solar panels on the rear slope is not compatible with the historic character of this small, one-story commercial building.*

**Application 2 (*Incompatible treatment*):** During the rehabilitation of this late-nineteenth century commercial building, a conspicuous rooftop monitor with prominent solar panels and skylights was constructed on the one-story structure. The size and finish of this rooftop addition are incompatible with the historic character of the building. However, the building could have accommodated both skylights and solar panels if they had been installed differently. An alternative design that could have met the Standards would have included low-profile skylights and solar panels concealed behind the parapet wall.

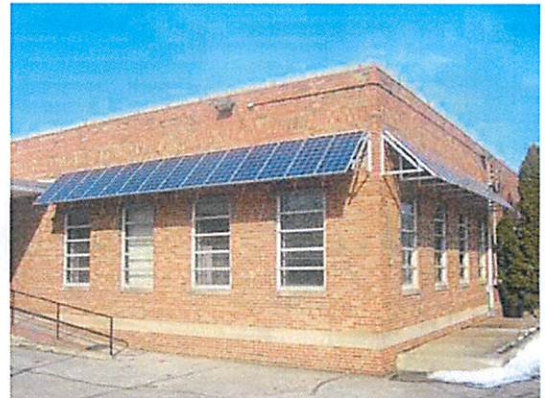
*Above: Shown from the rear of the property, these solar panels serve a secondary function as awnings to shade south-facing windows. Because of their location at the back of the building immediately adjacent to a loading dock, the installation of these panels does not affect the historic character of the property.*

**Application 3 (*Compatible treatment*):** The rehabilitation of this historic post office incorporated solar panels as dual-function features: generation of electricity and shading for south-facing windows. In this instance, the southern elevation of the building is also a secondary elevation with limited visibility from the public right of way. Additionally, because this area of the building is immediately next to the post office's loading dock, it has a more utilitarian character than the primary facades and, therefore, can better accommodate solar panels. Because the panels are in a suitable location at the rear of the property and are appropriately sized to serve as awnings, they do not affect the overall historic character of the property. Additionally, a screen of tall plantings shields the solar panels from view from the front of the building, further limiting their visibility.

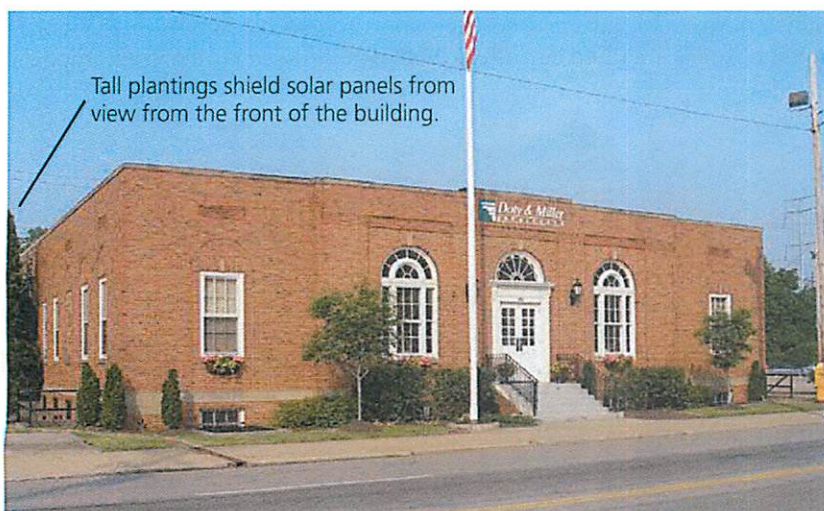
*Left: The solar panels are not visible from the front of the building. Additionally, even if the vegetation were removed, the installation would only be minimally visible along an alley at the rear of a secondary side elevation.*
